Compliance of Haditha Dam in Iraq to the International Standards for Surveillance and Monitoring

Alyaa Jumaah Hadi^{1,*}, Thamer Ahmed Mohammed²

Department of Water Resources Engineering, College of Engineering, University of Baghdad, Baghdad, Iraq
Alaia.Hadi2110m@coeng.uobaghdad.edu.iq, thamer.a.m@coeng.uobaghdad.edu.iq²

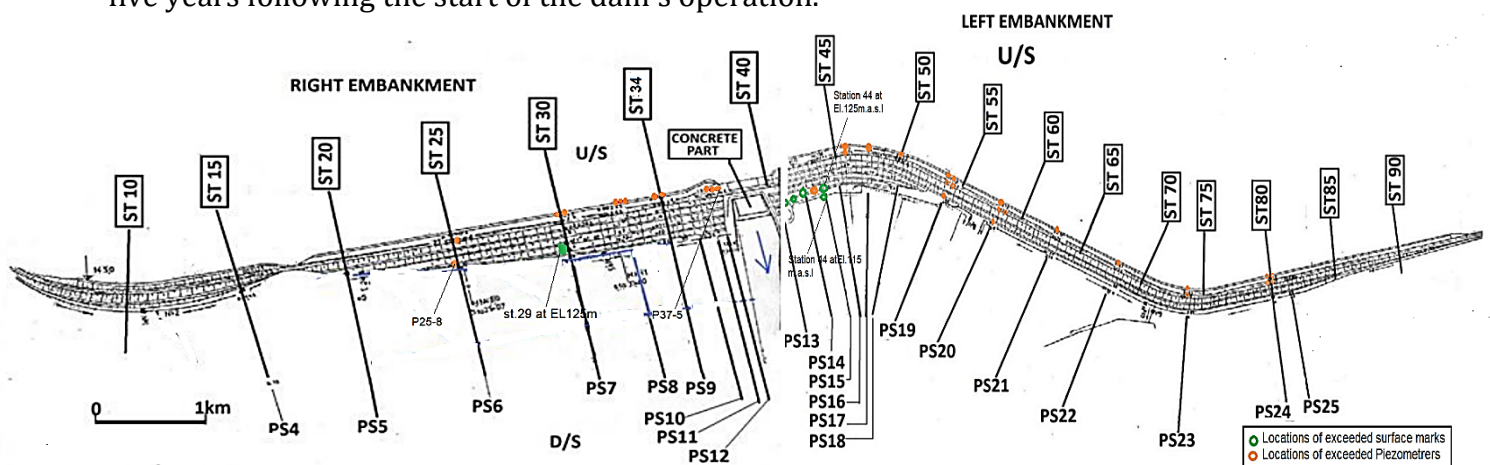
Figure 4. Locations of exceeded surface marks and piezometer level. (The State Commission of Dam and Reservoir, 2020)

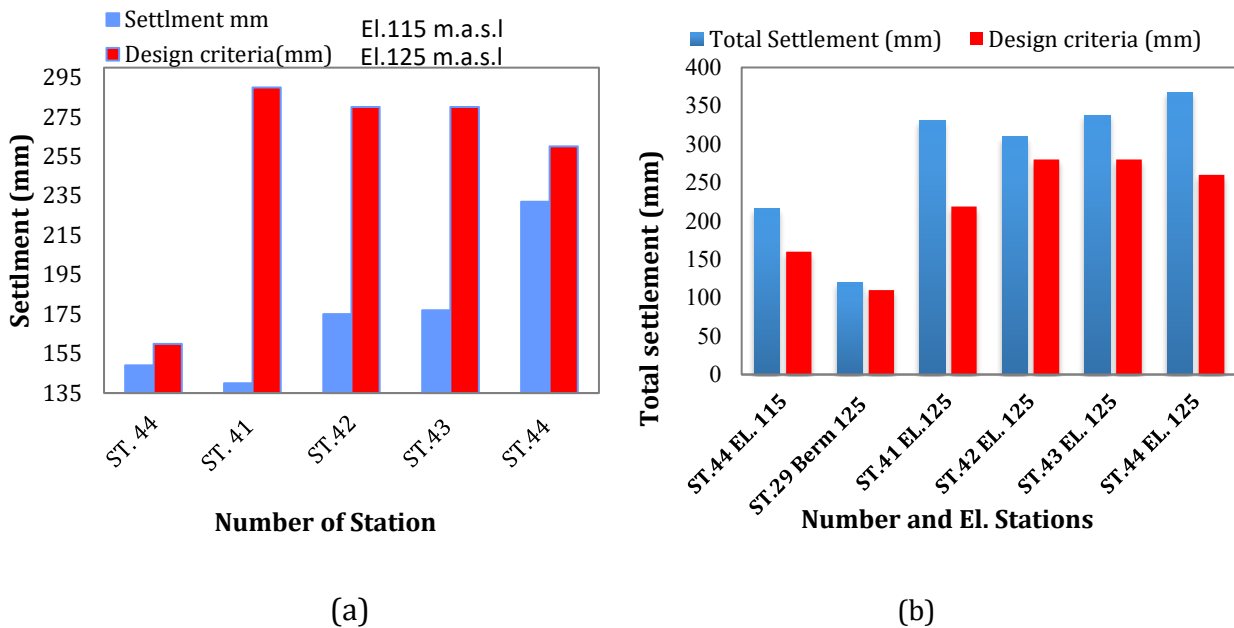
Fig. 5a shows the value of the recorded settlement on 1/1/1988 at the stations that exceeded the design criteria where the highest recorded settlement was found at station 41 at (EL. 125 m.a.s.l). **Fig. 5b** shows the total recorded settlement from 1/1/1988 to 19/11/2020 for the same stations the highest recorded settlement(331mm) was found at station 41 on the left side of the dam body exceeding the design criteria (219 mm) by about 51 %.

At station 44 (EL.115 m.a.s.l.), the lowest exceeded percentage was discovered to be 35%. All things considered, the data indicates that the dam's first year of filling saw the highest level of settlement. Subsequently, the documented settlement values decreased, indicating a tendency for the dam to stabilize. A study conducted by the United States Bureau of Reclamation (USBR) found that almost two-thirds of all dam failures were caused by internal erosion and that about half of all dam failures happened during the first filling or in the first five years following the start of the dam's operation.

Figure 5. Recorded settlement on the left side of the dam body from 1/1/1988 to 19/11/2020. (a) Recorded Settlement on 1/1/1988. (b) Total settlement from 1/1/1988 to 19/11/2020.

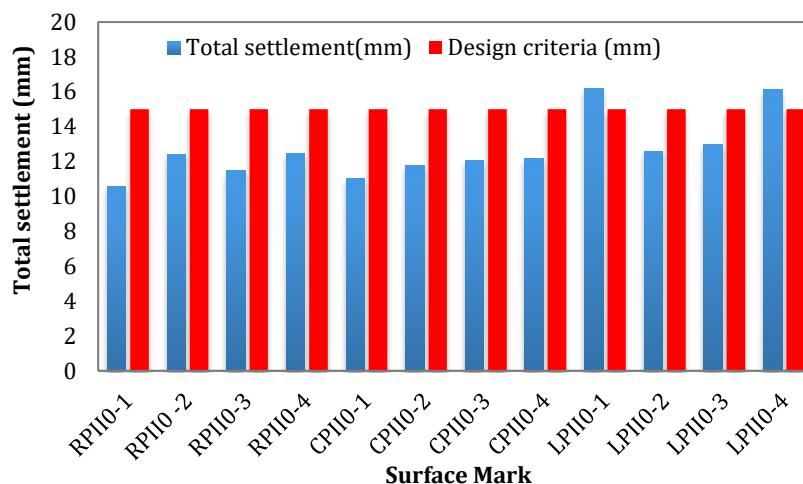
As seen in **Fig. 6**, the lowest recorded total settlement values at the left surface mark number (LP 110 - 1) were determined to be 16.2 mm, exceeding the design criteria by around 8%. At EL (141 m.a.s.l.), there are twelve surface marks. Four of them are situated on the left, center, and right. The recorded total settlement values between August 2002 and November 2020 were found to vary between 0.9 and 8 mm, although the design criteria value was 15 mm. Nothing exceeds the design parameters. Nonetheless, eight surface markings at EL.of (154 m.a.s.l.) were discovered to have total settlement values ranging from 0.7 mm to 5.7 mm between August 2002 and November 2020, despite the design parameters stating 15 mm. Also, no settlement values exceeded the design criteria.

Figure 6. Recorded total settlement for the surface mark at the Hydroelectric station at elevation 110 m.a.s.l.

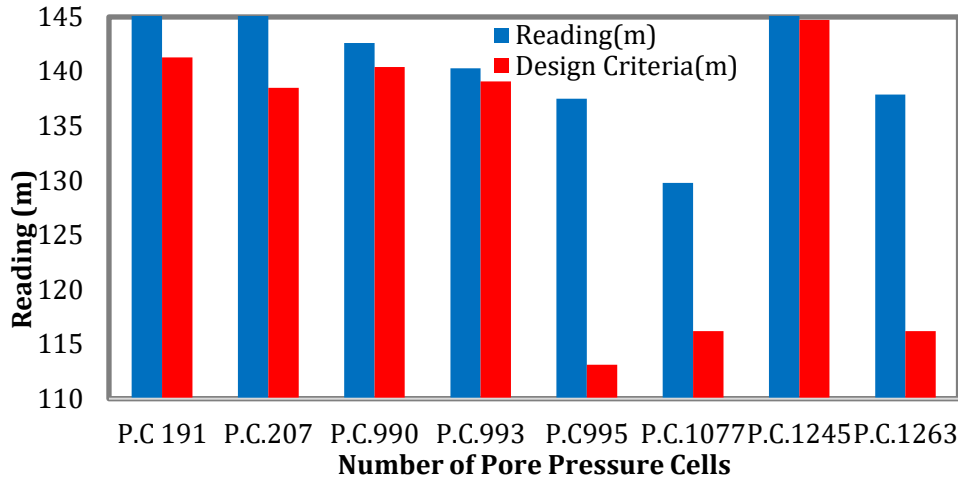
Figure 7. Exceeded pore pressure cells from 14/1/2020 to 7/12/2020.

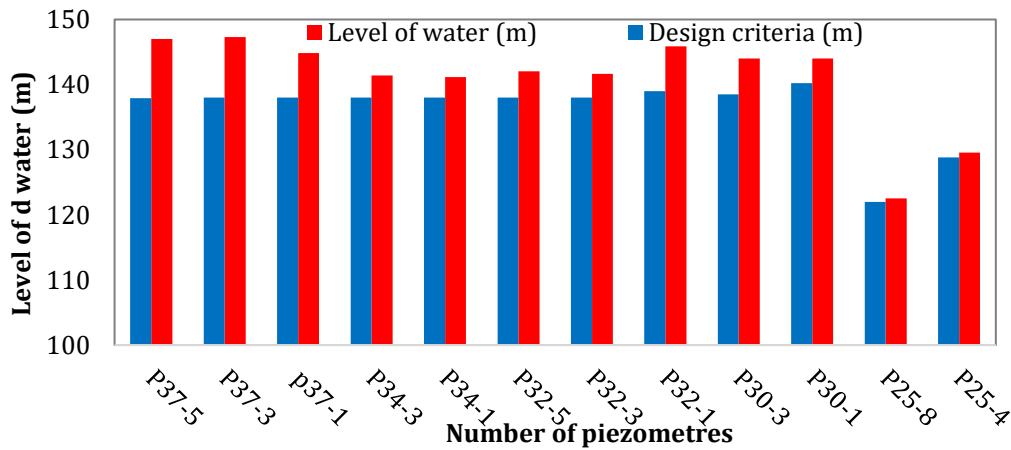
a. Piezometers of the dam body that exceeded design criteria on the right side

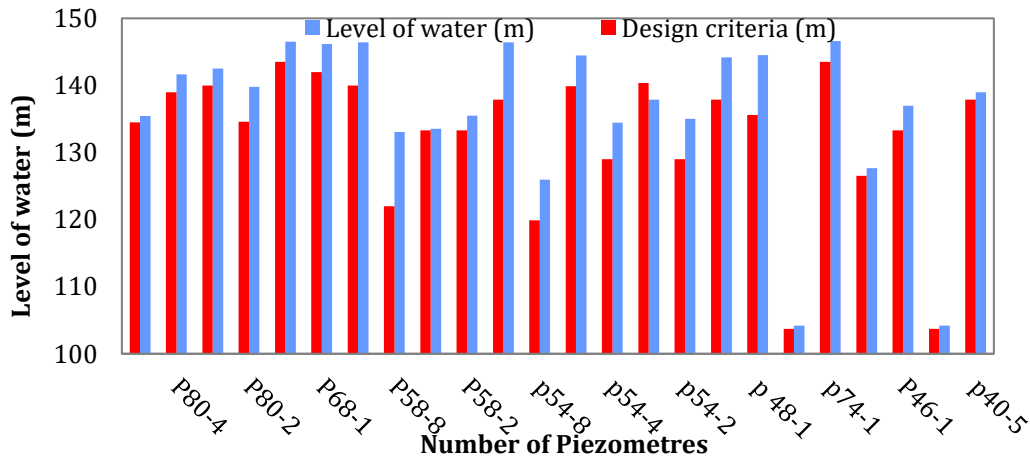
There are 86 piezometers on the right side of the dam body distributed along many stations (15,20,25,29,30, 31,32, 34, 36,37), the data collected from 5/1/2020 to 22/12/2020 was used in the assessment. Only readings from 12 piezometers were found to range from (122.54 to 147.32) m.a.s.l. which exceeded the design criteria (122 to 140.74) m.a.s.l. The highest exceedance percentage of 6.6% occurred at piezometers number 37-5 which are located close to the powerhouse while the lowest exceedance percentage of 0.44% occurred at piezometers number 25-8 as shown in **Fig. 8 a**. There are 104 piezometers on the left side of the dam body, 10 piezometers are dry or under maintenance, and in 22 piezometers the readings were found to range between (103.7 and 134.5) m.a.s.l which exceeded the design criteria (104.21 -146.59) m.a.s.l. A higher percentage of 9.1% was found at piezometers 58 - 8 which is located far from the powerhouse. The lowest percentage of exceedance was 0.49% and it occurred at piezometers number 43-8 as shown in **Fig. 8 b**.

b. Piezometers of the dam body that exceeded design criteria on the left side.

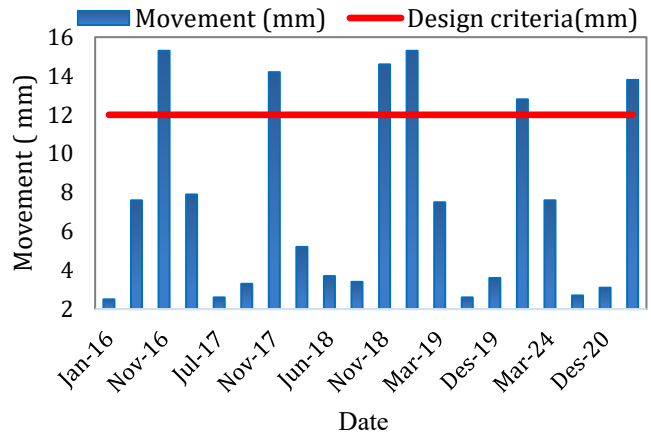
There are 18 devices to measure joint meters between the main blocks of the dam structure. The locations of the device are shown in **Fig. 9 a**. The measurements are carried out in three directions (A, B, C). The recorded measurement was from 1/6/2016 to 8/12/2020. The readings of movement of joint meters device number 10 (D10) ranged between 2.5 mm to 15.3 mm exceeding the design criteria (given as 12 mm in direction A). The readings of movement of (D15) ranged from 5.2 mm to 7mm which exceeded the design criteria (given as 5 mm in direction B). However, the reading of the movement of D18 ranged from 5.2 mm to 8.1 mm exceeding the design criteria (5mm). The highest percentage of movement at D18 is 62% and it occurred in the last pieces of concrete that separated the bottom outlets from the natural land while the lowest percentage of movement was occurred at D10 and found to be 6.6% (**Fig. 9 b and c**). No leakage was observed in these joints as there is no sign of a defect found in them, and the main reason may relate to the effect of temperature.

b. Measurement of exceeded device (D10).

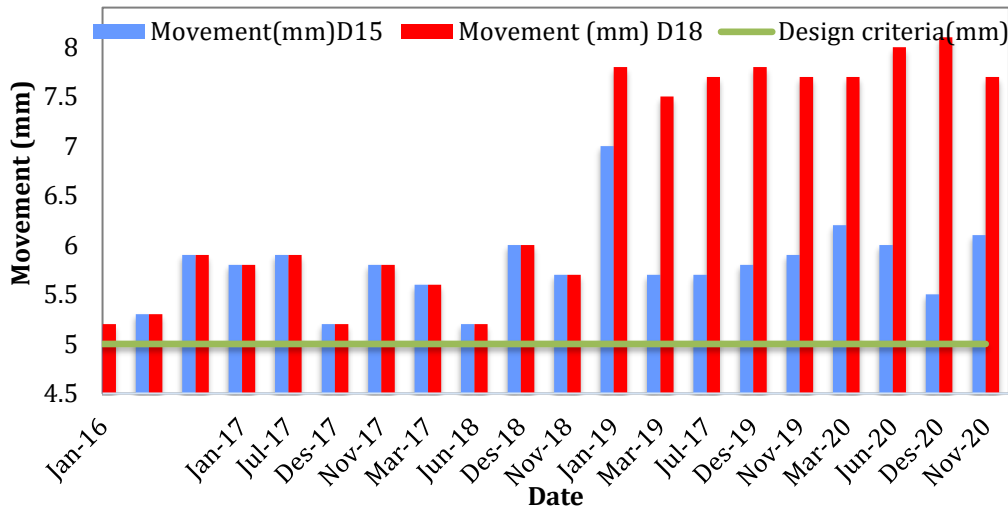
c. Measurement of exceeded device (D15, D18).

5. The measurements in three locations by joint meters device (D10, D15, D18) exceeded the limits by 62%, and this was recorded at join meter number D18. The frequency of measurements complied with most of the international standards.
