Civil and Architectural Engineering

Behavior of Defective Cast in Place Piles

ABSTRACT

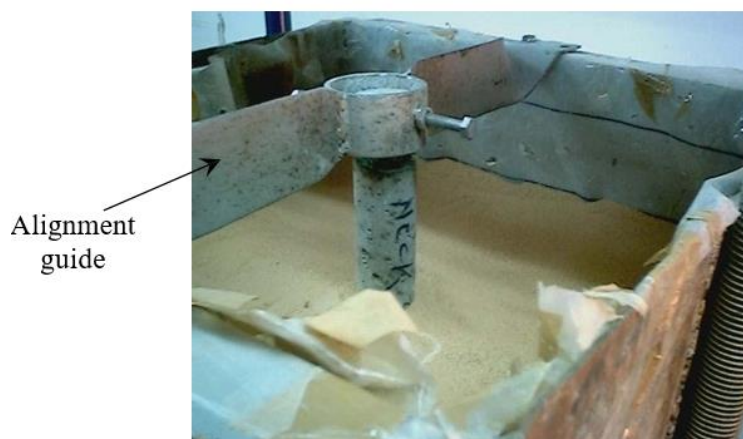
Plate 2. Special Guide to Adjust the Pile Model in Place.

A water balance was used to keep the pile axis vertical during the preparation of the test. The centring bar consisted of a small clamp, having two holes with screws used to fix the pile to the centring bar, and to fix the model pile in the required position.

The sand was poured in layers, 100 mm each, until reaching the bottom level of the model pile. After installing the model in its vertical position by the guide and the screw bolts that are attached, in such a way to ensure its central position and verticality, which was checked by the water balance. Resuming sand was then poured with a similar procedure to the designed level with special care to avoid disturbing the pile. After that the guide was removed carefully and the sand surface was levelled. Finally, the proving ring was fixed on top of the model, and the dial gauge was fixed in its position as shown in Plate (3).

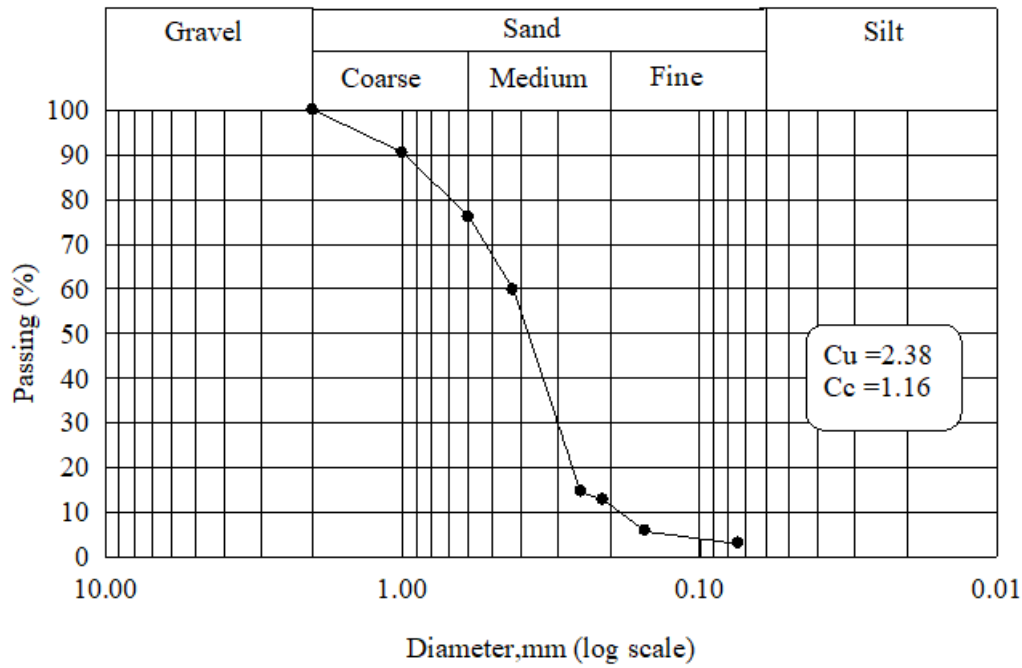
Figure 1. Grain Size Distribution Curve for the Tested Sand.

The grain size are analyzed according to the ASTM (D422-63). According to the grain size distribution curve shown in **Fig.1** the sand is classified as poorly graded sand with a coefficient of uniformity less than 6 and coefficient of curvature ($C_c = 1.16$).

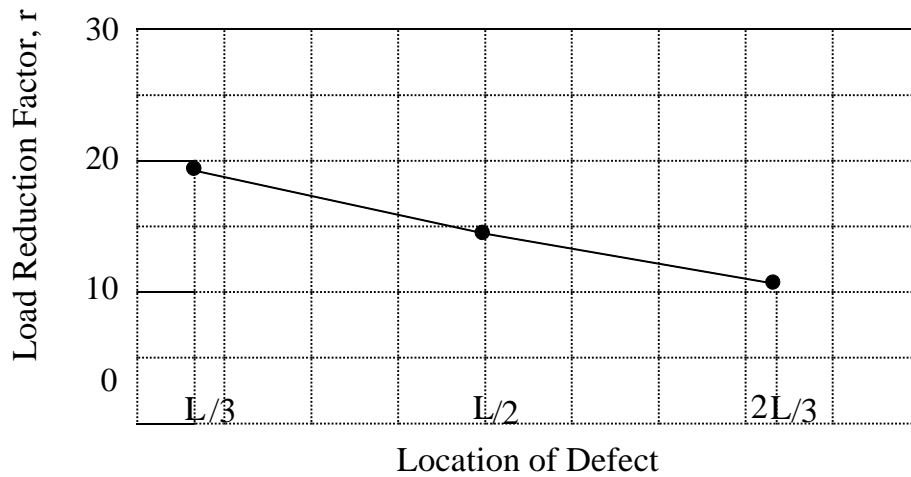
Figure 5. The Relation Between Load Reduction Factor (r) and Location of Defect.

Fig.5 shows the variation of the load reduction factor ($r = (1 - P_{ud}/P_{us}) \times 100$, where P_{ud} and P_{us} are the ultimate loads for defective and sound piles, respectively) with the location of defect along the pile. One could notice that the load reduction factor increases when the defect moves downward the pile.

The load reduction factor, r , decreased to about 10% when the location of the defect moves from $L/3$ to $2L/3$.

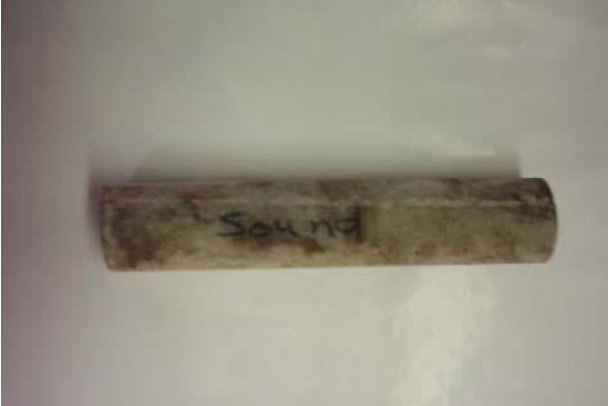
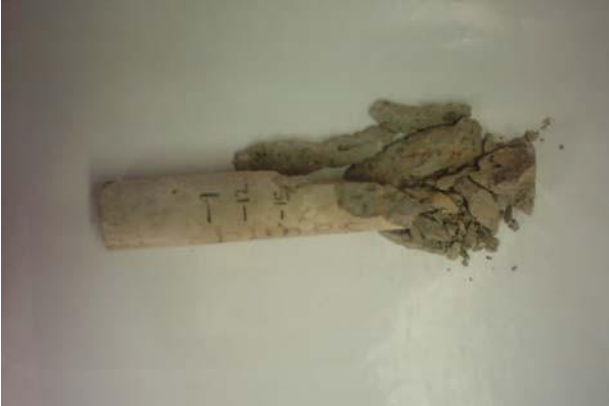
<p data-bbox="748 738 963 774">Photograph (1)</p>

In photo (1), a sound pile is shown before and after testing. The failure is shown to be at the first ($1/3$) of the pile length.

<ul style="list-style-type: none">- Sound pile.- 30 cm length.- $P_u = 58.4$ kN.

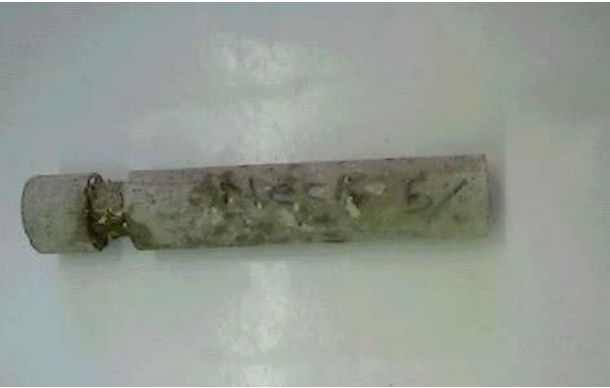
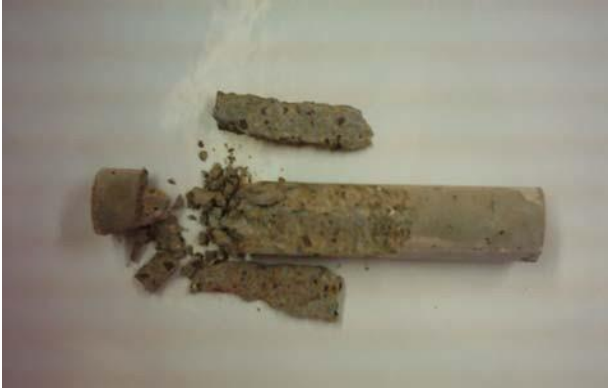
<p data-bbox="748 1204 963 1240">Photograph (2)</p>

In photo (2) to (4), defected piles with neck located at $L/3$, $L/2$ and $2L/3$ are presented, respectively. In all cases, the pile failed at the position of neck where the section of the pile is weak.

<ul style="list-style-type: none">- Defected pile (Neck).- 30 cm length.- Neck 5% at L/3.- $P_u = 28.21$ kN.

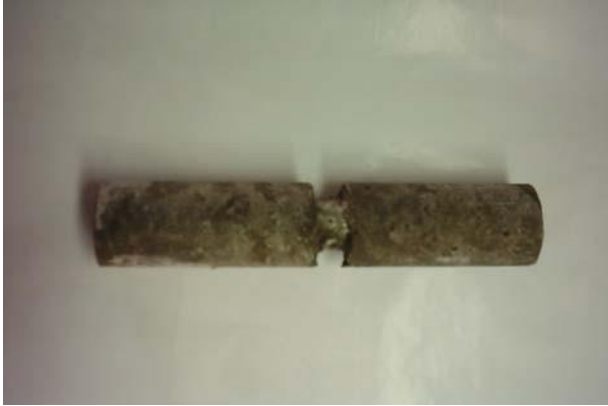
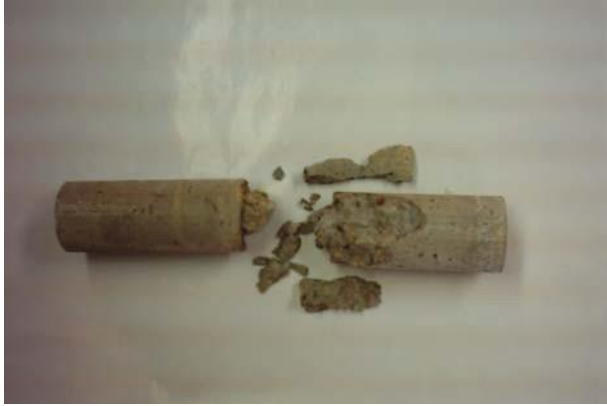
<p data-bbox="786 791 994 826">Photograph (3)</p>

<ul data-bbox="1608 368 1912 544" style="list-style-type: none">- Defected pile (Neck).- 30 cm length.- Neck 5% at L/2.- $P_u = 37.93$ kN.

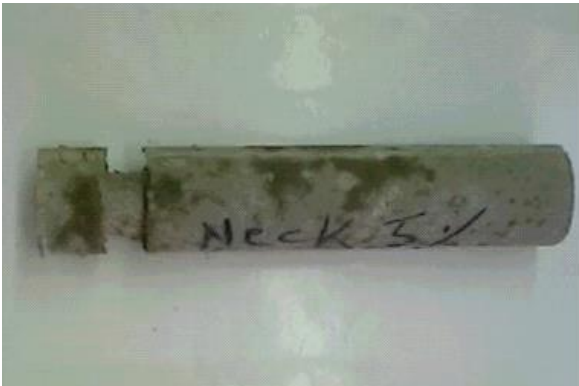
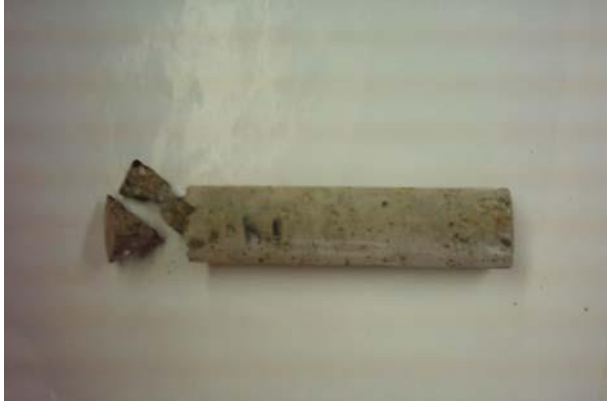
<p data-bbox="786 1270 994 1305">Photograph (4)</p>

<ul data-bbox="1608 850 1912 1026" style="list-style-type: none">- Defected pile (Neck).- 30 cm length.- Neck 5% at 2L/3.- $P_u = 43.4$ kN.

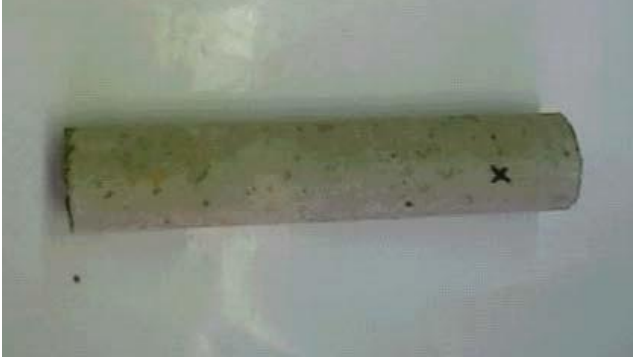
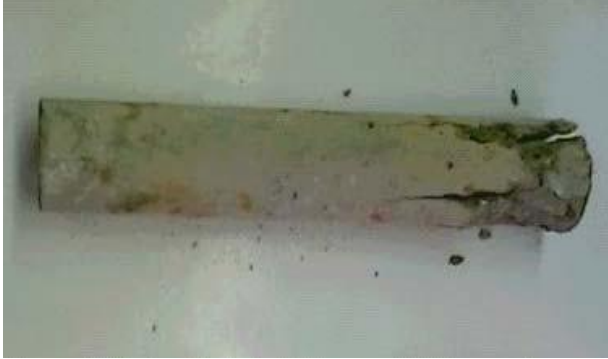
<p data-bbox="831 616 1039 651">Photograph (5)</p>

In photo (5) to (7), piles with internal void are presented. The voids are located at $L/3$, $L/2$ and $2L/3$, respectively. It can be seen that a wide crack propagates from the pile head or tip towards the void where a complete failure takes place.

<ul style="list-style-type: none">- Defected pile (Internal void).- 30 cm length.- Void 5% at L/3.- $P_u = 34.94$ kN.

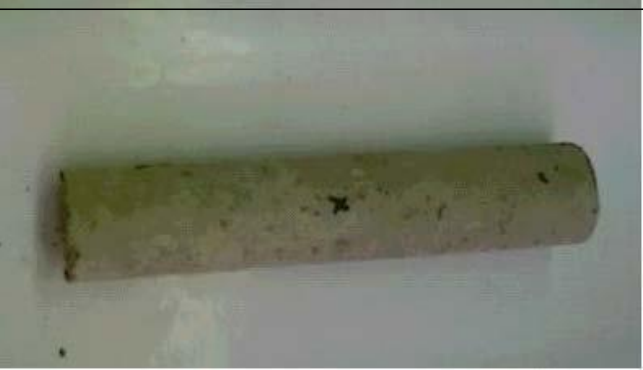
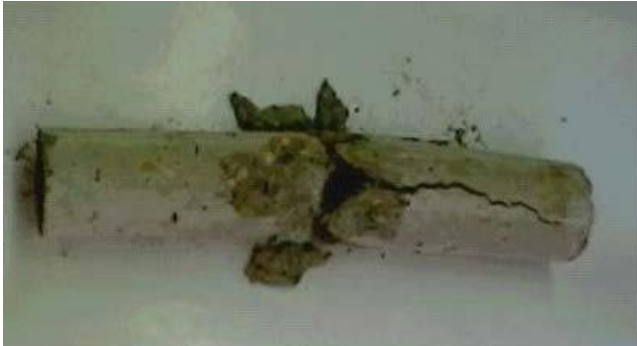
<p data-bbox="763 1078 972 1114">Photograph (6)</p>

<ul style="list-style-type: none">- Defected pile (Internal void).- 30 cm length.- Void 5% at L/2.- $P_u = 26.26$ kN.

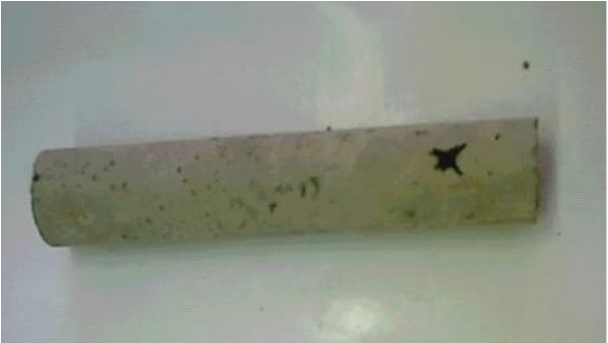
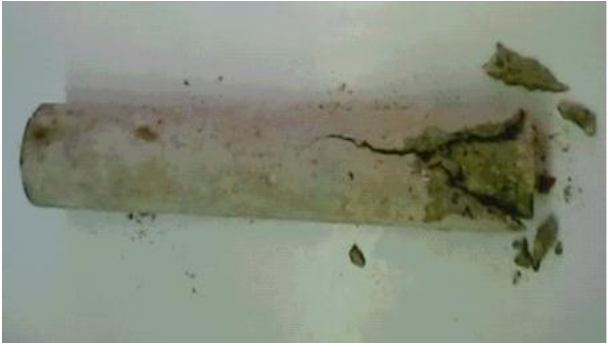
<p data-bbox="730 619 938 651">Photograph (7)</p>

<ul style="list-style-type: none">- Defected pile (Internal void).- 30 cm length.- Void 5% at $2L/3$.- $P_u = 39.28$ kN.

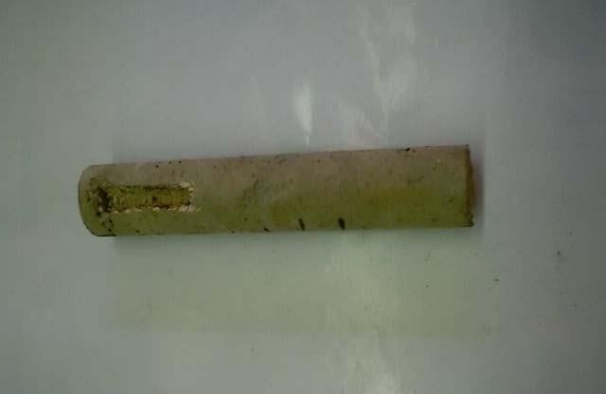
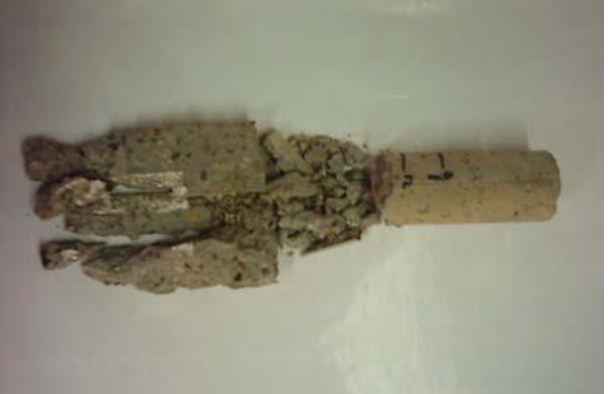
In photo (8), external void is made in the pile. The failure zone seems like a bulging has occurred in the first third of the pile length where the void is located.

<ul style="list-style-type: none">- Defected pile (external void).- 30 cm length.- Void 5% at $L/3$.- $P_u = 33.2$ kN.
