Impact of Anchored CFRP Composites on the Strengthening of Partially Damaged PC Girders

This manuscript investigated the effect of anchorage CFRP wrapping sheets, bolts, and laminate interlock on increasing the efficiency of flexural strengthening for the post-tension girder using CFRP composites techniques longitudinal laminates at the soffit for partially damaged loss of about 14.3% from its area of prestressed concrete beams, and the impact on restoring the original flexural capacity of PC girder. Mitigating delamination of the soffit of horizontal laminates (CFRP). The texture of the laminate and anchorages influenced the stress of the laminate carbon fiber, the mode of crack propagation and failure, and consequently, the beam's attitude has been investigated in this manuscript. The experimental findings demonstrated that using CFRP laminates significantly affects strand strain, especially when anchorage wrapping is applied. The laminates CFRP-EB enhanced the flexural capacity by around 13% of the original strength, which equates to a 13% increase in strand damage. Despite an increase in flexural capacity of 20%, 22%, and 29% when using anchorage wrapping, mechanical bolts, an

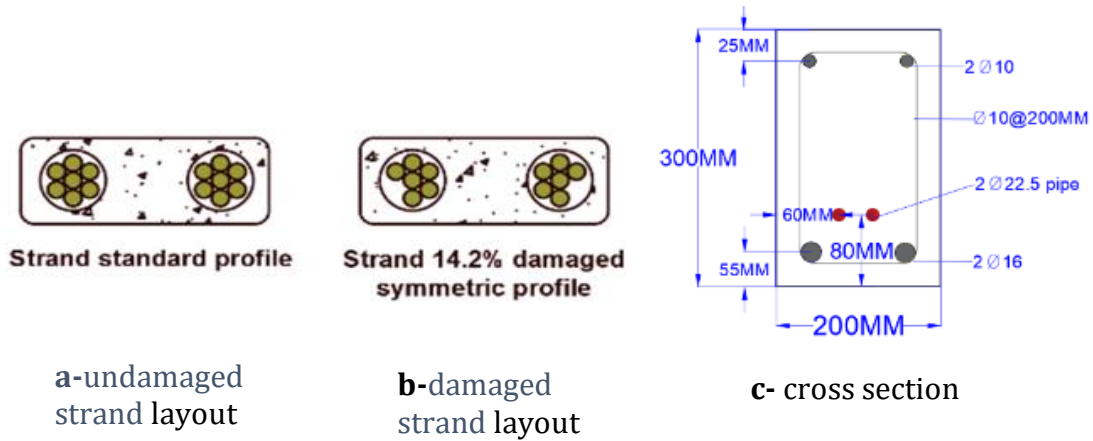
Figure 2. Cross-sectional detail and strand damage a-undamaged strand layout, b-damaged strand layout, c- cross-section

This study employs seven girders, as depicted in **Table 1**. The overall length is 3000 mm, and support by simple ends (hinge and roller) is 2800 mm distant with 2- ϕ 16mm rebars at the bottom, while for the compression zone 2- ϕ 10 mm are equipped (non-continuous), stirrups reinforcement was designed by using 10mm rebars with spacing as indicated in **Figure 1**. PVC conduit is employed to occupy the strand with a diameter equal to 22.5 mm consisting of end grips utilizing two unbonded strands that stretch 500mm from each side. All tests were conducted in the laboratory of Baghdad University's College of Engineering under four points of loading, as depicted in **Figs. 1 to 3**. CFRP Laminates (50mm and 1.2mm for the width and thickness respectively) are affixed to the soffit to reinforce the specimen.

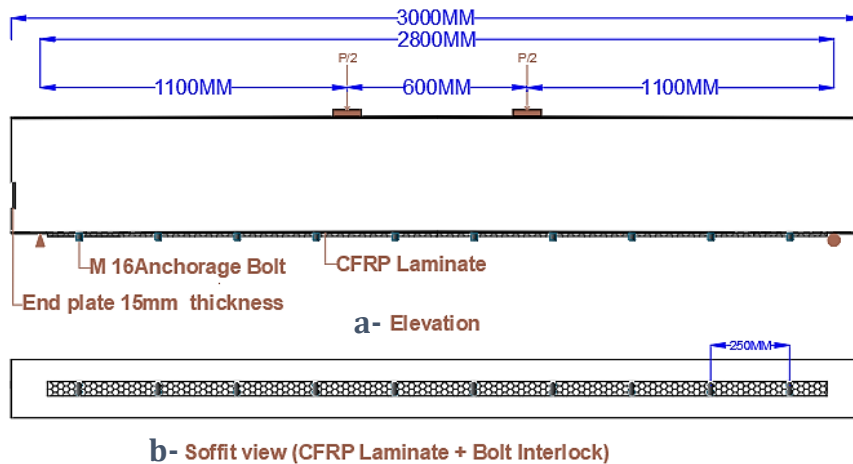
Figure 7. Laminate and mechanical bolts anchorage, a- elevation b- soffit view

The anchorage sheet thickness is 0.167mm built up on a U-wrapping form while the anchorage interlock laminate that is coupled is divided into three strips attached in the transverse direction at the soffit, 16mm of bolts diameter have been used for the mechanical anchorage techniques as illustrated in Fig. 4 to 7.

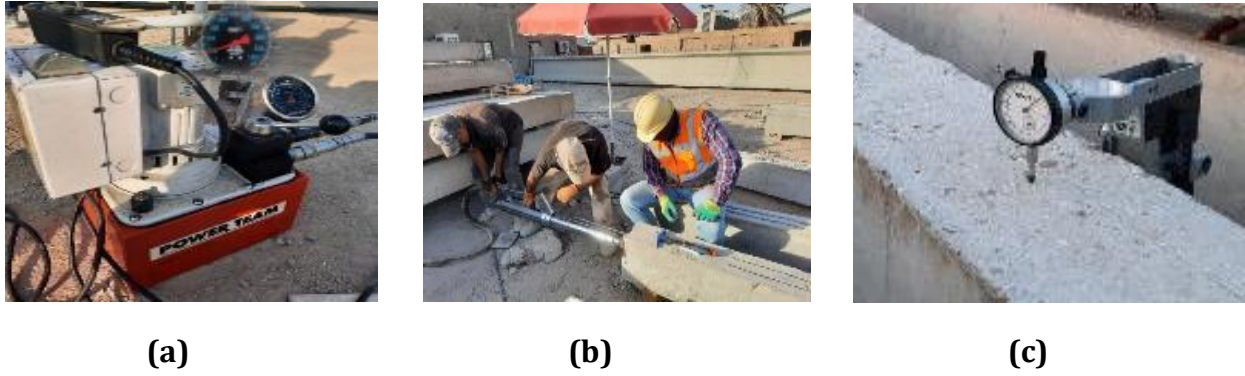
Figure 8. Operation of post-tensioning, a-PS equipment; b- PS process; c- camber recording

The steel cages were equipped with electric strain gages before being inserted in a mould made for Plywood for casting reinforced concrete. Utilize ready-mixed reinforced concrete. As illustrated in **Fig. 8**. As well as for the camber measuring the dial indicator fixed at the mid-span, the electronic strain indicator's wires were connected to the strain data acquisition device (Datalogger) to record the strand 's strain throughout the prestressing operation.

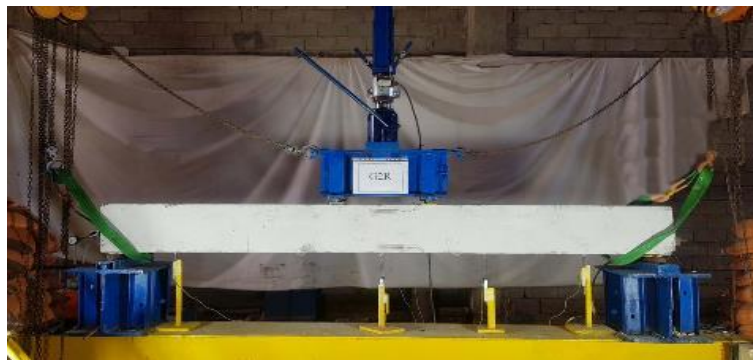
Figure 9. Member setup on the tested frame

Two dial indicators are fitted to each lateral end of the strand to measure strand slippage during the loading procedure. Four LVDTs were used to record the displacement of the tested members; two of them are fixed 10cm away from support, one below the mid-span, and the fourth set up at the quarter of a percent; all LVDTs were calibrated to zero strains at the start of the test, as depicted in **Figure 9**.

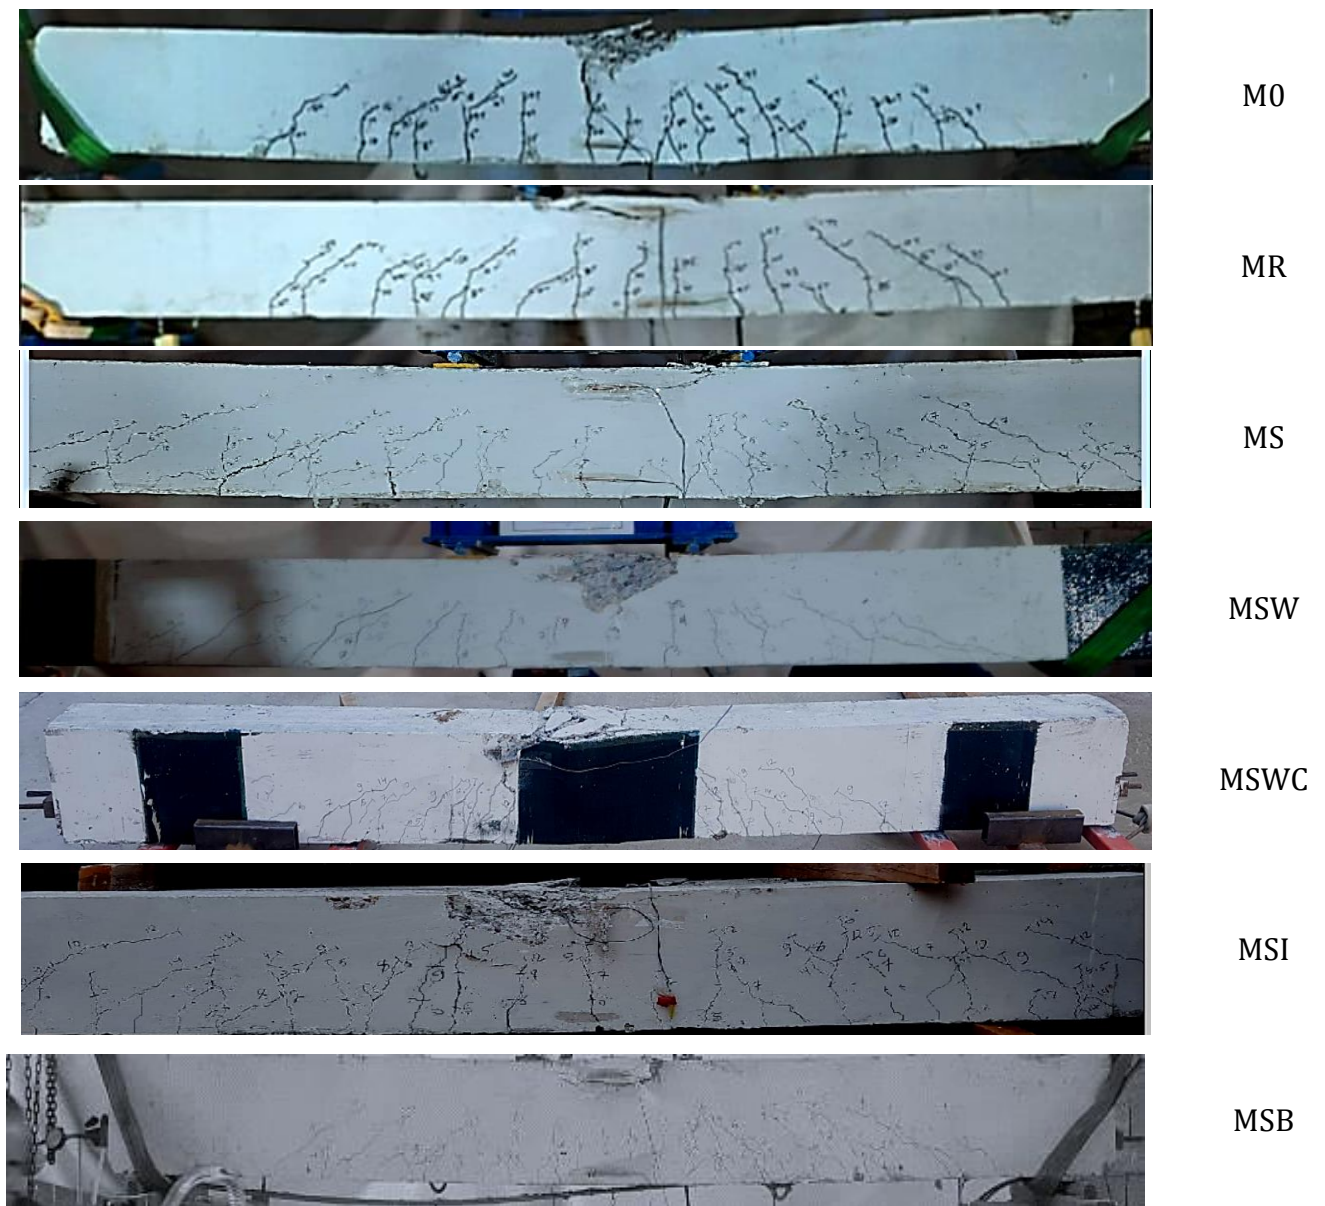
Figure 10. Crack pattern for the members

To incrementally boost the load, a hydraulic jack with a capacity of 50 tons was installed at the top of a load cell, and 15 kN increments were considered as loading steps until the breaking load capacity was reached. Then the load increased by increments of 30 kN until failure occurred. The testing of each beam requires around 130 to 170 minutes. The load cell indicator was utilized to record each increment of applied load coming from the experimental frame of the test as well as to gather the massive reading data output, which gives output data for the load as it was continuously applied from the frame indicated for each load step after the fracture emerged. After the test, two sides fracture pattern of the cross-section was taken and marked with markers. Failure modes and ultimate loads were given for each instance. During the experimental testing, the first crack, the crack pattern illustrated in Fig. 10, and load-deflection were observed.

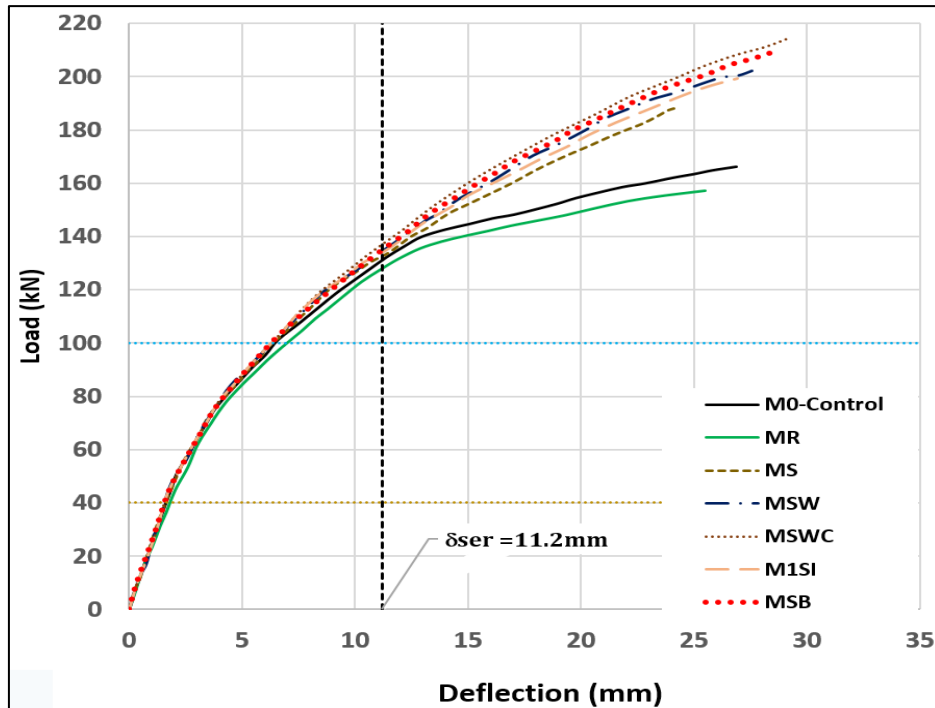
Figure 11. Load vs. displacement curve

As depicted in **Figure 11** below, tested members were examined at three different distinct load stages: cracking loads, post-cracking elastic stage, and ultimate loads capacity. When the applied load is below the cracking load value, the laminates (CFRP) and tendons do not impact the specimen's behavior. The results show that they lose strength when compared to the control member (undamaged); however, the reinforced members with laminated showed an improvement in the flexural capacity of 13%, and member strengthening with laminate and different anchorage techniques varies from 22%, up to 29%, implying the sound of the using of anchorage effect on the enhancement of strength and ductility due to the impact of delaying of debonding between longitudinal laminate and concrete surface **Table 3**.

The stiffness of the reference girders drops marginally, while the stiffness of the reinforced members is not much different from that of the damaged girders. When the applied loads from the testing frame for flexural strength increase and surpass the value of the cracking load, the member that is exposed to 14.3% of the cutting strand exhibits a relatively high value of stiffness drop due to the lack of a portion of the pre-stressing flexural force, which increases the average of crack and displacement development. Similarly, the flexural CFRP strengthening EB of the laminates demonstrate their ability to delay the fracture formation and stiffness degradation of the strengthened girders, and the girders strengthened with laminates and debonding-enhanced anchors are observed to be superior to the girders strengthened with laminates alone.

According to the control result, the displacement at the serviceability limit ($L/250$) is 11.2mm, and this value is pointed as the permitted load, which is approximately 78.5% of the maximum load. During this stage, the displacement of the reinforced girders was exposed to a 10% reduction for MS and about 15% for the anchorage members. It should be figured out that in each instance, the member with the anchoring has a smaller load drop, substantially greater stiffness, and greater strength. The CFRP girders strengthened with CFRP laminate and different types of anchorage exhibit an increase in deflection at the maximum load due to the lack of a relatively gradual decrease in load after the onset of partial degradation, as well as the ability of the members with an anchor to keep their ductile response. The ultimate displacement increased significantly when the specimens were strengthened with laminates alone and laminated with anchorage.

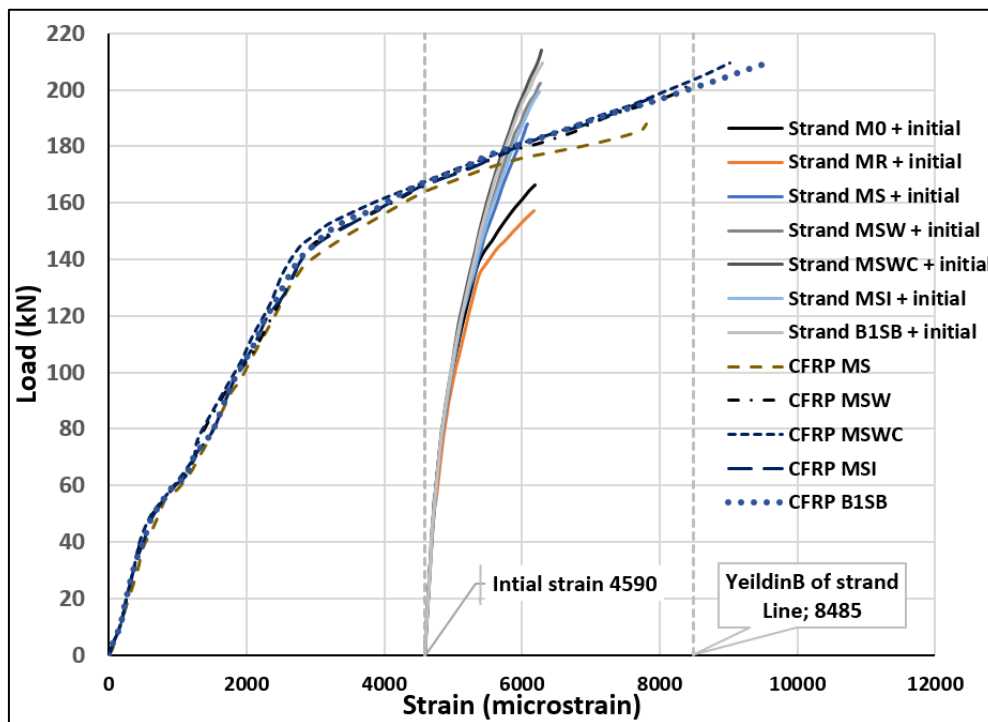
Figure 12. Load Vs. the strain of CFRP and PS

Before the cracking load, the strain in CFRP laminates in **Figure 12** below is minimum and almost equal. After the load exceeds the breaking threshold, the strain visibly increases, and after the tension rebar yields, the average strain increase expedites dramatically. The increased strain average in laminates made from carbon fibre-reinforced polymer with or without anchorage techniques was nearly identical, but the ultimate strain of the strain increases in carbon fibre-reinforced polymer laminates with anchors was significantly more than its counterpart in those members without anchorage. At the serviceability load stage, the strain increases of strengthened designed members MS was 0.27%, which corresponded to 13.3% of the strain rate of laminate capacity (ultimate breaking = 2%) with no significant change to the specimen that was strengthened with laminate and anchorage MSW, MSWC, MSI, and MSB. In contrast, the strain increase at the ultimate loads was 1% for MS, corresponding to 41.5 % of the maximum strain of the fiber elongation capacity. In contrast, the specimens strengthened with laminate anchorage demonstrated more strain at the ultimate load. In addition, using FRP laminates with anchorage had an essential effect on the compressive concrete zone strain. As previously described, the CFRP laminates can prevent the formation of cracks in their course.

Due to the insignificant strain increases, the strand wasn't contributing to flexural strength before the onset of the first crack. The change in strand strain was estimated by subtracting the initial effective strain after prestressing (4,500 micro-strains) from the strain value recorded. **Figure 12**. The strand behaved identically in all investigated members over this loading phase. The increased strain in the strand for the damaged member was more than

in the undamaged girder. However, the increased strain in the strand for the members reinforced with CFRP laminate was smaller than the strain increases in the strand for the unreinforced member. At the serviceability stage, the increase in strand strain for members MR was 7500, representing an increase of about 9%, compared to the undamaged member. Similarly, the strain increments in the strands of the reinforced member's MS 6750, with a decrease of 15% compared to the parallel strain increases in the damaged member references.

Compared to the control and damaged girder, the reinforced member's MS showed substantially less strand strain increases in the loading level following the load in the level of serviceability than the control and damaged members. Increases in tendon strain were reduced by 14.67% for B1SW when end anchors were utilized. All of the results mentioned above and analyses have demonstrated that the carbon fibre-reinforced polymer strengthened by laminates, including anchors, has a presumed effect on the attitude of the strands. As indicated before, the CFRP laminates could postpone and avoid the evolution of cracks, as well as slow the loss of member stiffness.

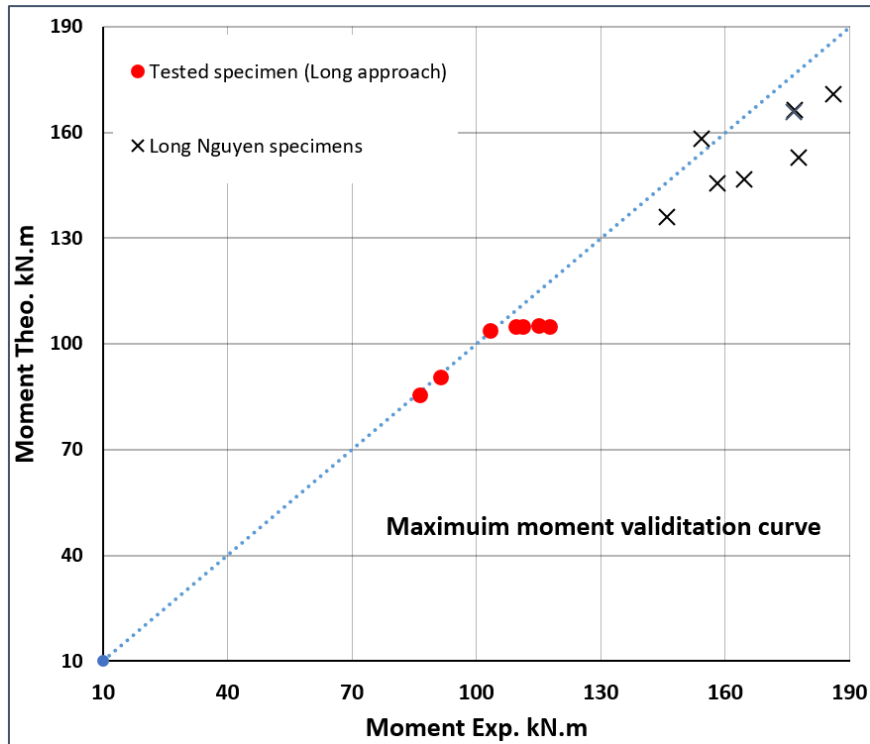
Figure 13. Flexural capacity experimental and predictions result

Table 4 and **Figure 13** exhibit the predicted-to-experimental flexural strength ratios μ , predicated μ , and experimental. The "mean value" $\text{Avg.} = 94\%$ and "coefficient of variance" $\text{COV} = 5.1\%$ describe the precision of predicated flexural strength values and their applicability for predicting the flexural CFRP strength EB reinforced unbonded prestressed concrete member including or does not include and without anchorages.
