## Retrofitting Reinforced Concrete One-Way Damaged Slabs Exposed to High Temperature

Shireen Awad Abbas  
University of Anbar M.  
Sc Civil Engineering

### ABSTRACT:

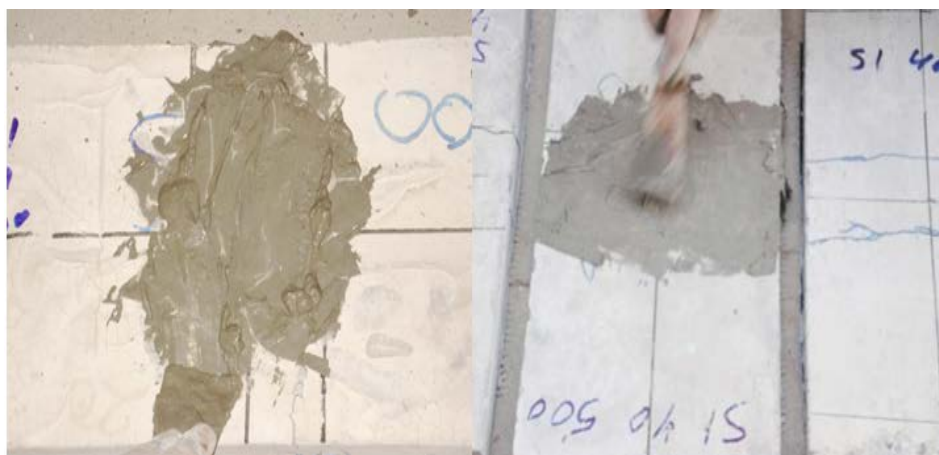
**Figure 3: Repair of damaged and spalled areas of concrete with mortar (1 cement + 1 sand) at top and bottom surfaces.**

After burning slab at high temperature and loading until failure, the slab was overturned (upside down) so that retrofitting should be done on its bottom surface. In order to ensure correct application of the external strengthening materials and to remove the deformation (curved shape) due to the loading at the first stage (after burning the specimens and before retrofitting them), it was considered necessary to improve the concrete surface characteristics on the contact areas to be bonded . It included removing the cement paste, The spalled areas at corner of slabs were patched conventional concrete repair methodologies, grinding the surface by using an electrical hand grinder, and removing the dust generated by surface grinding using an air blower. After that the primer was applied to repair surfaces with non-shedding brush. The adhesive was applied to the tension face of the slab Sikadur<sup>®</sup>-330 (two-part epoxy impregnation resin) was used in this work for the bonding of CFRP sheet. The two-part epoxy was mixed according to the manufacturer's specification: 4 parts resin to 1 part hardener by weight. The epoxy system was thoroughly hand mixed for at least 3 minutes at room temperature. The CFRP sheets placed in the bottom of slab after applying thin layer of epoxy. The time gap between the CFRP sheets bonding and the slab test was at least 7days. The procedure of applying of CFRP is shown in **Figs. 3 to 6**.

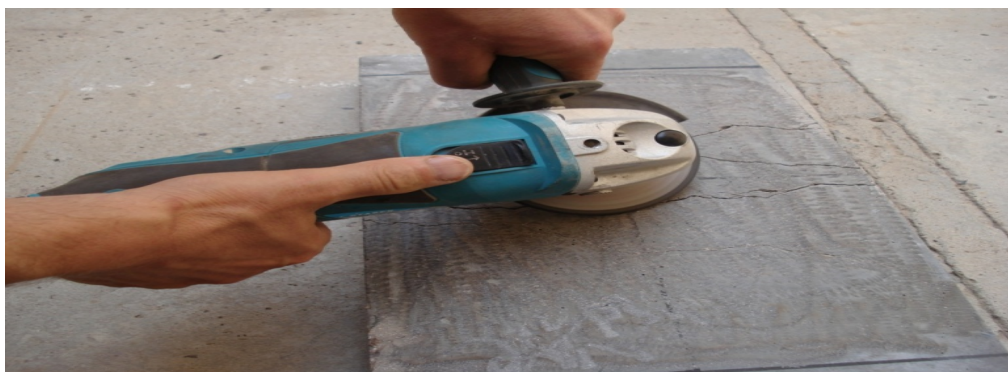
**Figure 4: Concrete surface preparation by grinding**

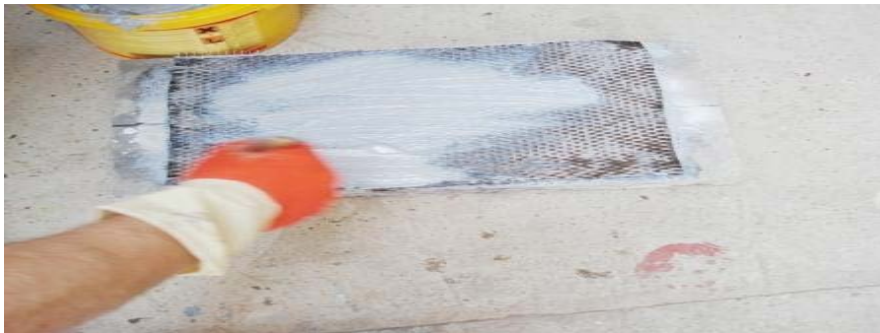
**Figure 6 : Coating of the second layer of CFRP with a layer of epoxy.**

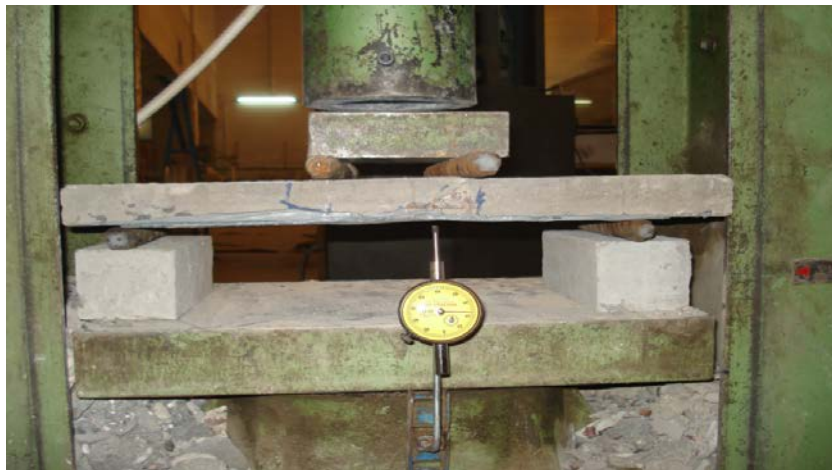
**Figure 7 : Testing of specimens under two point loads**

All specimens were loaded by two point loads until failure using hydraulic testing machine in the Structural Laboratory at the College of Engineering of Baghdad University as shown in **Fig. 7**. The distance between the specimen supports was 400mm and the distance between each point load was 100mm. Deflection of the slab specimens was measured at mid-span using a dial gauge with travel distance of 50 mm and accuracy of 0.01 mm.

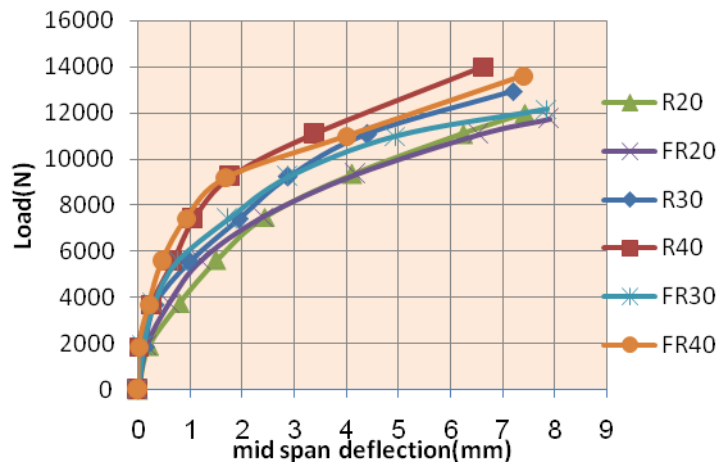
Figure 8 :load-mid span deflection relation of reference slab before and after retrofitting(R&FR) of different concrete strength

The stiffness of specimens R and specimens FR were nearly identical as shown in **Fig. 8**. Similar remarks have been made by **[Obaidat et al, 2010]**. It should be noted that repair of reference slabs after loaded allowed recovering the original stiffness.

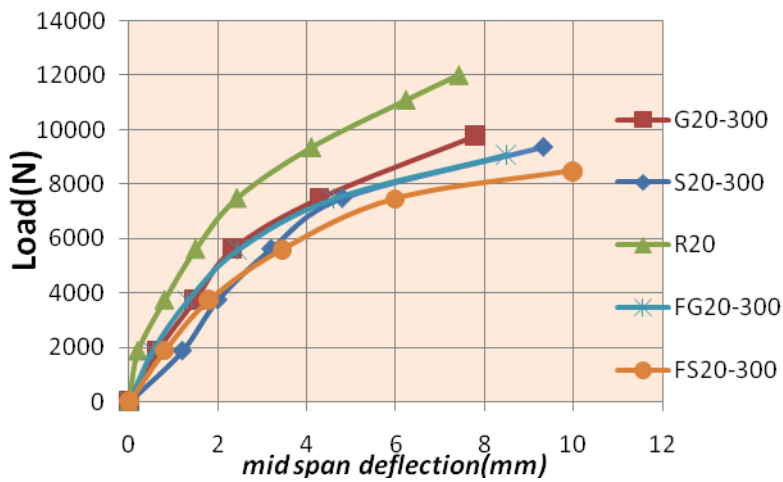
Figure 9 : Load-mid span deflection relation of slabs before and after retrofitting of  $f'_c=20\text{MPa}$  subjected to  $300^\circ\text{C}$  temperature with both cooling methods

Slab specimens FG and FS for all compressive strength at all exposure temperature showed decreases in stiffness when compared with the of reference slab specimen R. The stiffness of specimens (FG and FS) is higher than (G and S) respectively at the earlier loading stage. After initiating new cracks or growing the old cracks due to loading, the stiffness of (FG and FS) is decreases than (G and S) respectively as shown in **Figs. 9 to 11**. It should be noted that repair groups (S) and (G) could not restore the stiffness to the level of the reference slabs.

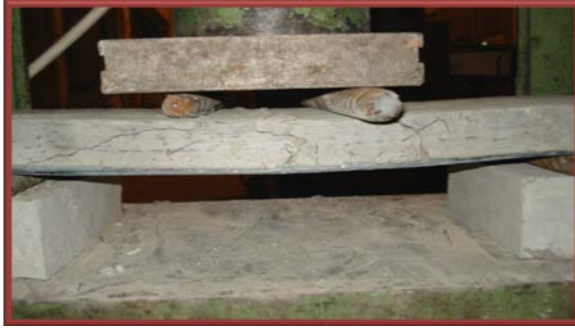
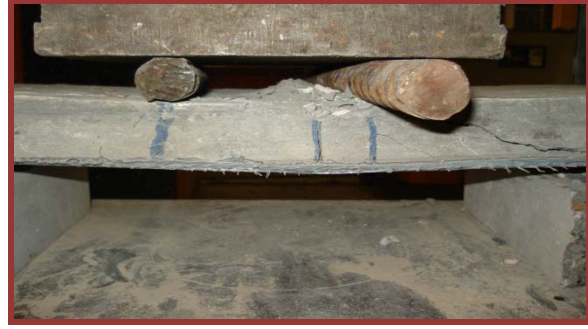
Failure of specimen FR30-300.

Failure of specimen FS20-300.

A) Crushing of concrete at compression zone

In general, most of the tested slabs failed by concrete crushing at mid span and partial debonding of certain retrofitting systems was also observed for a few cases. For all slabs subjected to 300 °C temperature and slabs FR group, few flexural cracks started first at the constant moment region, also few diagonal cracks near the supports were observed, with increasing applied load, one of these cracks developed diagonally to the nearest loading point. The slabs failed by crushing of the concrete in high moment region on the top surface and debonding was not observed with high elongate as shown in **Fig. 12-A** similar failure pattern was observed by [Ramanathan,2008] who noted that failure was characterized by compression failure of the concrete in the constant moment region on the top surface of slabs which should be expected for a section having a short effective depth.

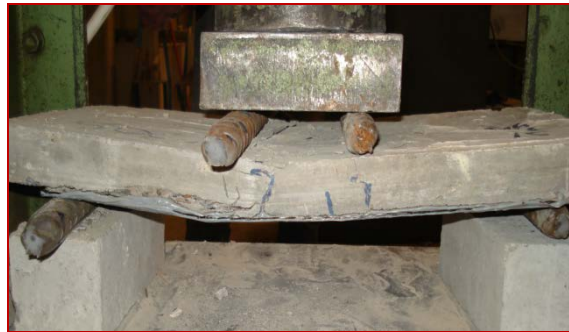
Failure of specimen FG20-500

B) cracking started in concrete layer between the CFRP and the embedded longitudinal steel reinforcement

For all slabs subjected to (500) °C temperature ,cracking started in concrete layer between the CFRP and the embedded longitudinal steel reinforcement. The slab failed by crushing of the concrete on the top surface and CFRP debonding was not observed as shown in **Fig. 12-B** for slab FG20-500.

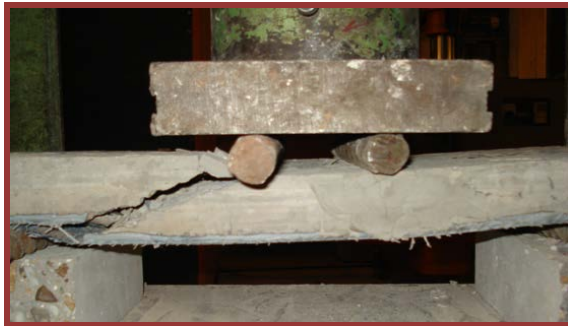
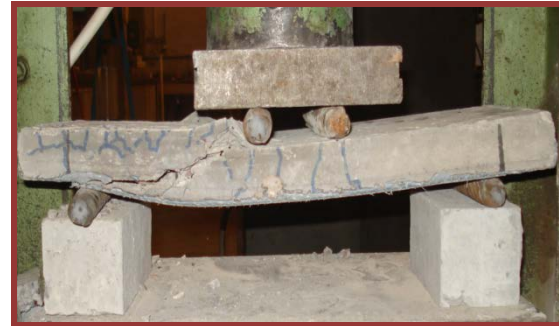
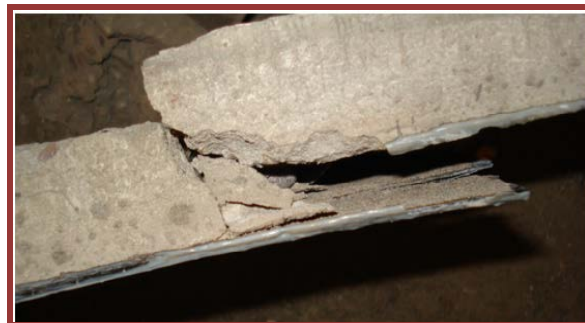
Failure of specimen FG40-700

Failure of specimen FS40-700

Mid span debonding of Specimen FS20-700

C) Critical diagonal crack with debonding of CFRP sheet starting brittle failure

For slabs FG20-700 , FG40-700 and FS40-700, the failure was by critical diagonal crack with debonding of CFRP sheet starting at the critical diagonal crack under point load and proceeded toward the support. The failure was extremely brittle and occurred at one end of the slab emanating from the support as shown in **Fig. 12-C** for slab FS40-700 and FG40-700. This type of collapse has also been reported as a failure mechanism for the externally bonded FRP on RC one-way

slab systems [Ramanathan,2008]. For slabs FS20-700 , FG30-700 and FS30-700, diagonal crack originated under an external load point in the region of combined highest moment and shear and propagated toward the support .This crack generated high stresses in the CFRP sheet. Since the concrete could not maintain the interface shear and normal stresses, the CFRP separation was initiated at the location where the diagonal crack contacted the CFRP and propagated in the direction of decreasing moment (toward the support). Failure of the test specimen was by CFRP debonding at the end span with sudden failure by complete separation of the concrete as shown in **Fig. 12-C** for slab FS20-70. This type of collapse has also been reported as a failure mechanism for the externally bonded FRP on RC one-way slab systems [Karbhari et al. ,1999; Tann, 2003 ;Ramanathan,2008; Shadhan,2011].

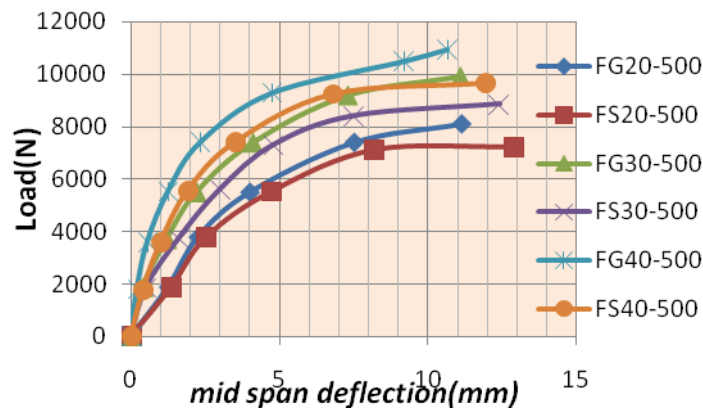
**Figure 13 : Load-mid span deflection relation of retrofitted slabs(FG&Fs ) with different compressive strength concrete (20MPa ,30MPa and 40MPa) at :**  
(A) exposure temperature 300°C  
(B) exposure temperature 500°C  
(C) exposure temperature 700°C

Considering the diagrams in **Fig. 13** it can be concluded that the specimens with high

compressive strength show more stiff behavior than slabs with low compressive strength at all exposure temperature . The effect of exposure temperature was very clear on both slabs FG and FS, **Fig. 14** show the comparison between specimens with different exposure temperature at the same compressive strength, the stiffness increased when the temperature decreased. When comparison are made between (FG) and (FS) for all compressive strength at all exposure temperature, it was shown that the stiffness of specimens cooled suddenly are lower than that specimens cooled gradually. This is because of the formation and propagating of the cracks due to the burning process, which had a great effect on the rigidity of the slab specimens, causing a high mid-span deflection. Also, the rate of cooling affects this propagation of cracks, where it increased as the rate of cooling increased, resulting in decrease in the rigidity and increase in deflection. In addition to the more cracks which allowed to higher debonding between the concrete and the steel bars. The ultimate loads of the specimens cooled suddenly were less than the specimens cooled gradually for the same compressive strength concrete because of the more minor cracks in the specimens cooled suddenly by water resulted in reducing in the bonding between the steel bars and concrete

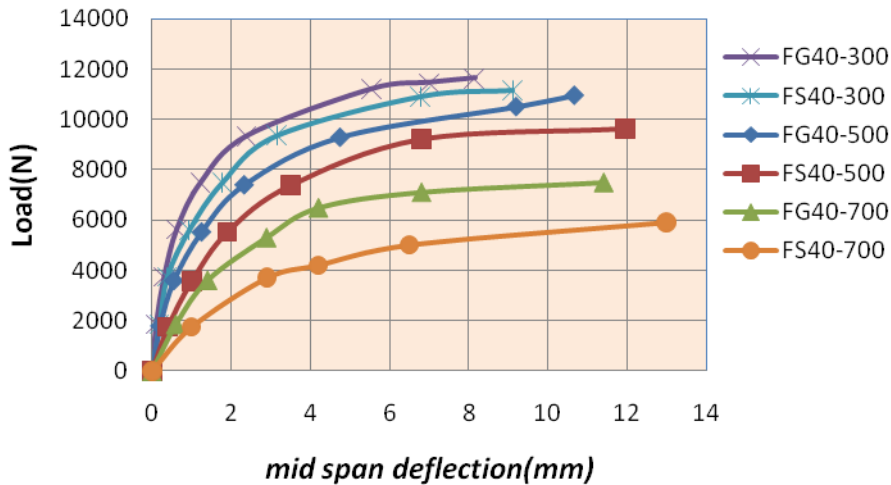
Figure 14 : Load-mid span deflection relation of retrofitted slabs FG & FS with different exposure temperatures (300 , 500 and 700) $C^0$  for:  
 (A) compressive strength concrete(20MPa)  
 (B) compressive strength concrete(30MPa)  
 (C) compressive strength concrete(40MPa)
