EXPERIMENTAL INVESTIGATION OF REINFORCED CONCRETE FLEXURAL BEAMS STRENGTHENED OR REPAIRED WITH CFRP

Prof. Dr. Husain M. Husain*

Assist. Prof. Dr. Nazar K. Al-Oukaili**

DAWLAT D. ALI

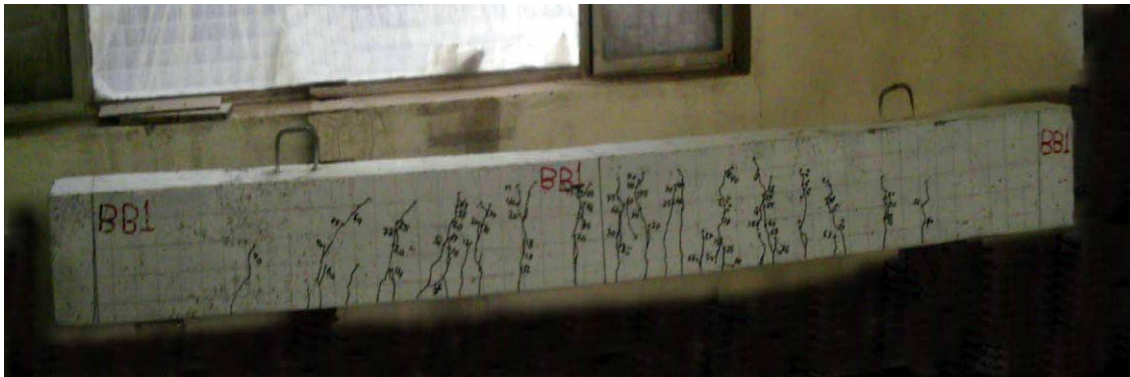
Figure 6 Crack pattern for beam BB1- control beam

In the present study, the cracks initiated from the bottom concrete surface at the maximum moment region and moved upwards but did not reach the top fiber compression zone. Figures 6 and 7 show photographs for crack patterns for the control beams (BB1) and (BB2).

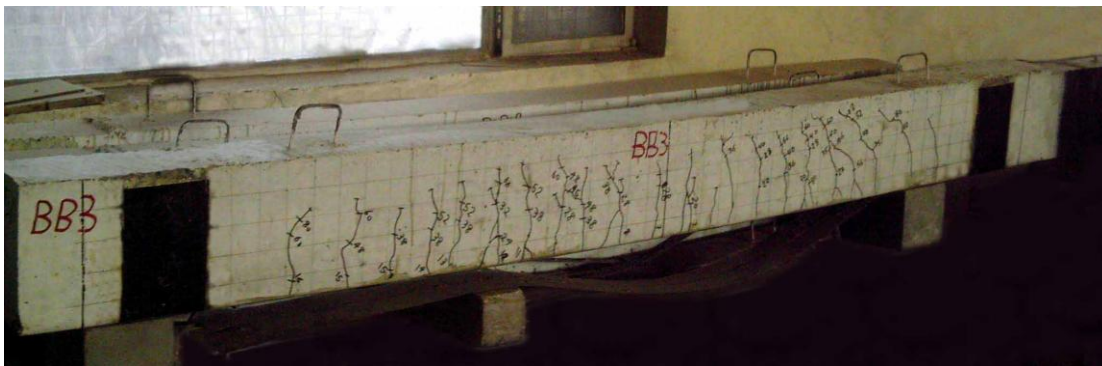
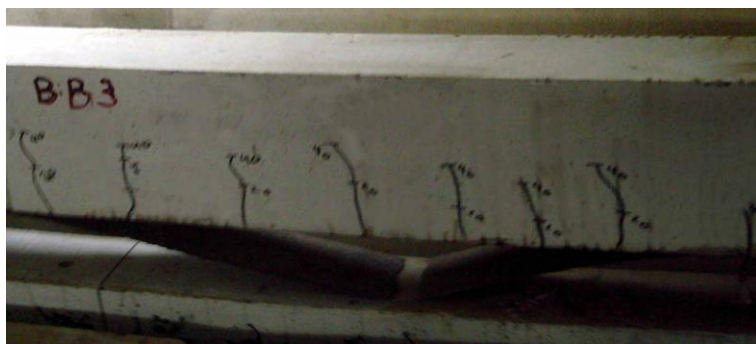
Figures 8 and 9 show the crack pattern for a beam strengthened with CFRP located at the bottom face of the beam. No major shear crack was noticed. Failure occurred by yielding of reinforcement and followed by CFRP rupture.

Figure 8 Crack pattern for beam BB3- strengthened beam (bottom face). **(a)** Cracks on overall beam. **(b)** Magnified picture for cracks at mid-span.

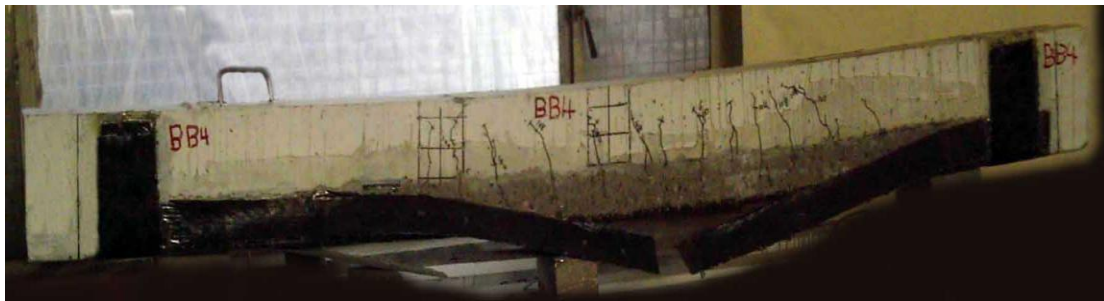
Figures 10 and 11 show the crack pattern for a beam strengthened with CFRP located at the bottom and side faces of the beam. The crack initially developed at bottom (tension zone). It is seen that the number of cracks has been reduced significantly due to presence of side face CFRP sheets. The beam failed before the cracks reach the top fiber. Failure occurred by yielding of reinforcement and followed by CFRP failure at the maximum moment zone (cut of the bottom CFRP and followed in the side CFRP sheets).

Figure 10 Crack pattern for beam BB4- strengthened beam (at bottom and side face by CFRP sheets). **(a)** Cracks on overall beam. **(b)** Magnified picture for cracks at mid-span.

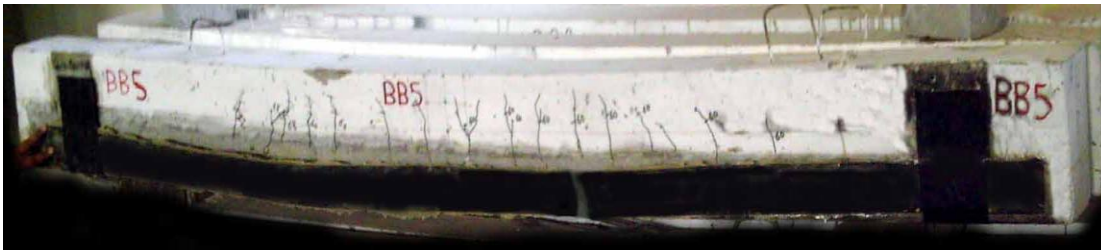
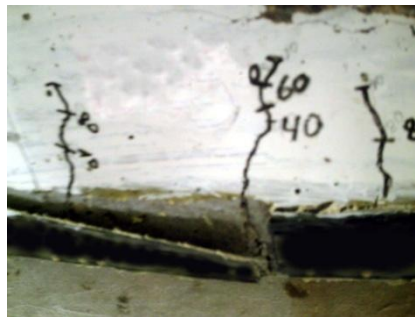
Figures 12 and 13 show the crack pattern for a beam strengthened with CFRP located at the sides of the beam only. Also, the cracks started in the (tension zone) and moved towards compression zone while the number of cracks was reduced due to presence of side face CFRP sheets. The beam failed before the cracks reach to the top fiber. Failure developed by yielding of reinforcement and followed by CFRP failure.

Figure 12 Crack pattern for beam BB5- strengthened beam (at sides of beam). (a) Cracks on overall beam. (b) Magnified picture for cracks at mid-span.

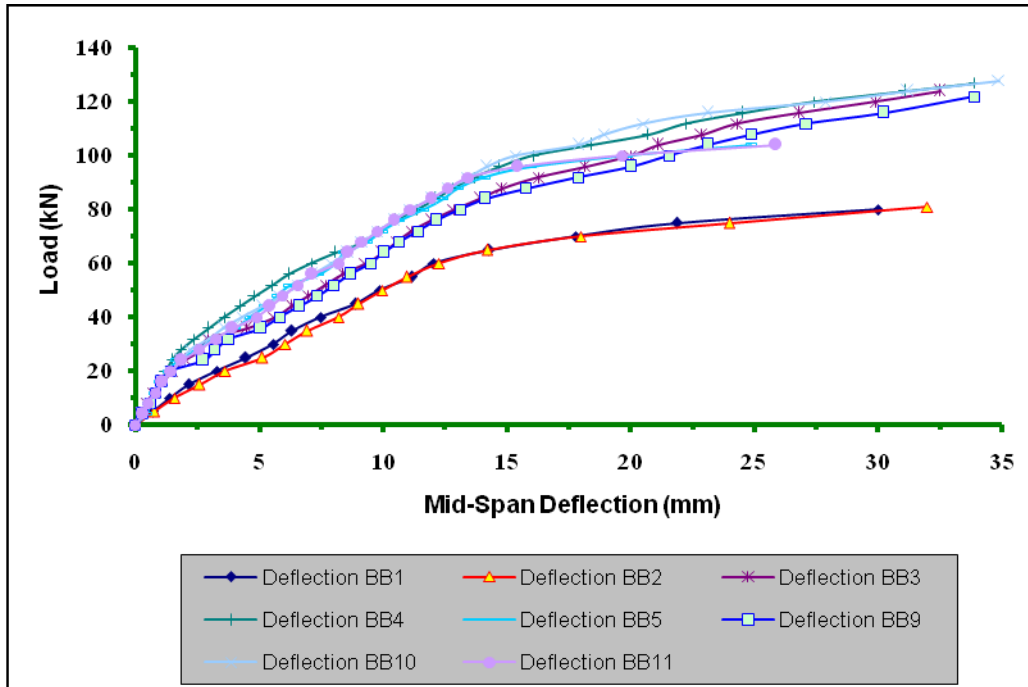
Figure 21 Load-deflection comparisons between strengthened and control beams

Load versus central deflection curves for the tested beams that had been constructed and tested to fail in flexure are shown in Figures 21 and 22. Figure 21 shows the load-deflection curves for the control and strengthened beams. Figure 22 show the load deflection curves for the control and repaired beams. The enhancement in stiffness and ultimate load by CFRP sheets is clear in these figures.
