Retrofitting of Reinforced Concrete Damaged Short Column Exposed to High Temperature

Asst. Prof. Dr. Amer Farouk Izzat
Department of Civil Engineering
College of Engineering
University of Baghdad
amerfarouk@yahoo.com

Key words: retrofitting, reinforced concrete column, CFRP, high temperature

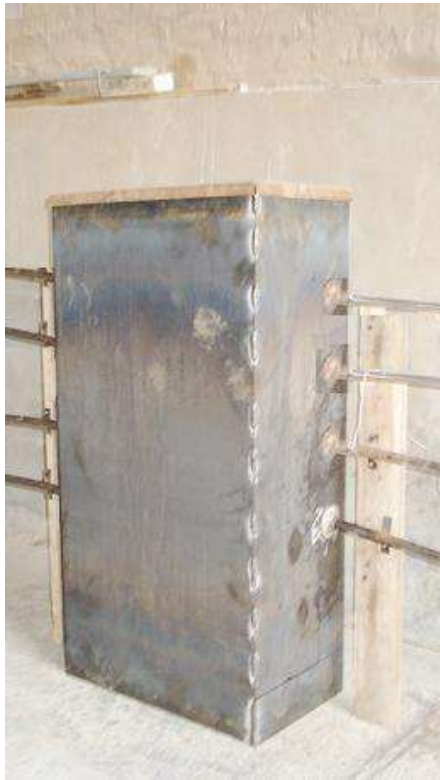
A- furnace with nozzles

B- Specimen positioning in the furnace

Figure 2. Details of furnace, distribution of the nozzles and specimen position in the furnace during burning

Two column specimens were left unburned as control specimens C₁ and C₇. The other specimens were burned in a furnace constructed of 3mm thick steel plate, as shown in **Fig. 2**. One column was burned at a time with three control cube specimens (100mm x 100mm x 100mm). Also three cubes were used to determine the strength of the concrete before burning. Furnace dimensions were: height: 800mm; width: 500mm; length: 400mm. These dimensions were appropriate for the dimensions of the specimens, to maintain enough space to allow the flames to reach them from the fire sources (nozzles). The nozzles were positioned eccentrically, four on each side of the furnace, as shown in **Fig. 2-A**, to distribute the fire flame over the entire height of the specimen. The specimen was rotated and positioned in the furnace, as shown in

Fig. 2-B to direct the flames from a series of methane burners positioned on two sides of the furnace onto the four faces of the specimen.

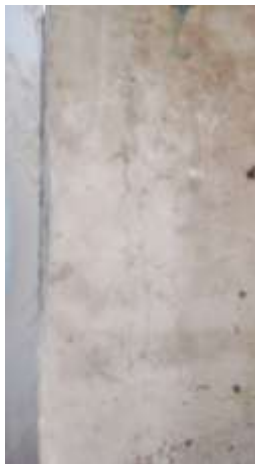
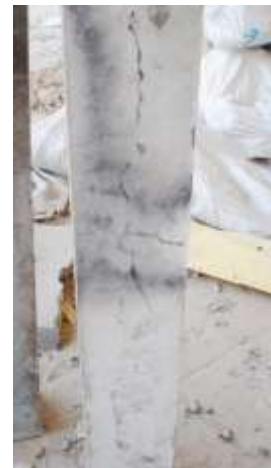
A- Column specimen C₄ after exposure to 500 °C and cooled suddenly

B- specimen C₆ after exposure to 700 °C and cooled suddenly

C- specimen C₅ after exposed to 700 °C and cooled gradually

Figure 3 . Crack formation at different conditions of cooling and exposure temperature before the loading test.

Column specimens damaged by exposure to the fire flame were loaded till failure after cooling. Cracks had formed throughout the burning and cooling processes, and spalling of the concrete covers had occurred, especially at corners. This phenomenon was observed at high temperature exposure of 700 °C, **Khoury, 2000**. Also some specimens spalled during the loading stages. Furthermore, the color of the concrete had changed to pink, perhaps due to the hydration of iron oxide and other minerals in the cement and the aggregate, **Neville, 1995**, as shown in **Fig 3**. Failure of the burned concrete specimens occurred in all cases due to crushing under different axial loads, as shown in **Table 7**. and **Fig. 4**.

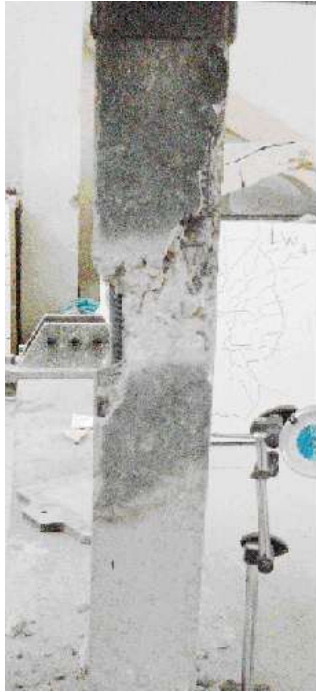
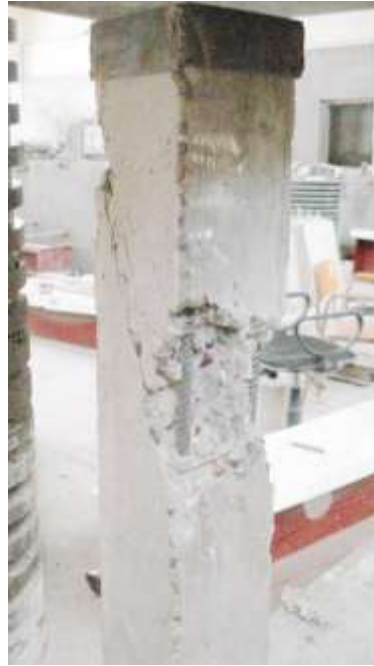
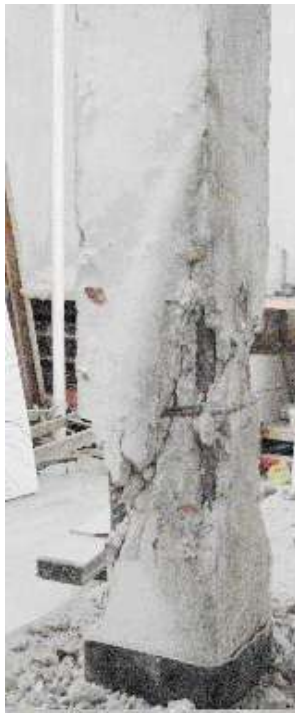
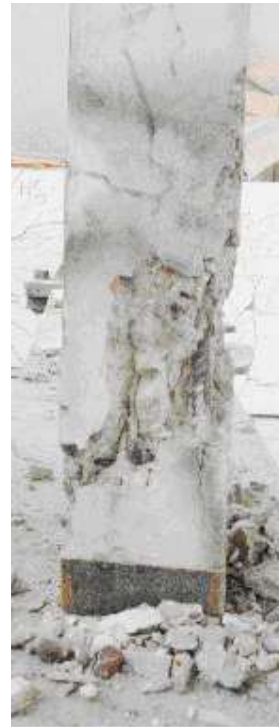
A- Column specimen C₅

B- Column specimen C₆

A- Column specimen C₁₁

B- Column specimen C₁₂

Figure 4. Failure mode of several column specimens after burning and loading till failure

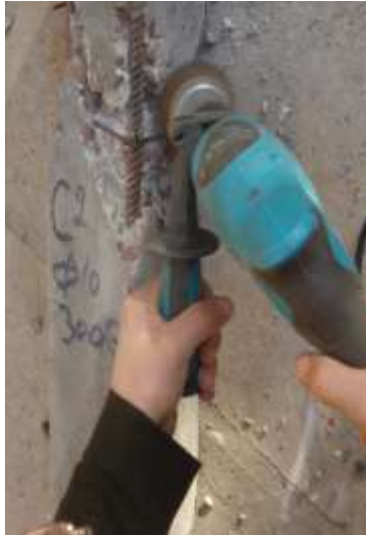
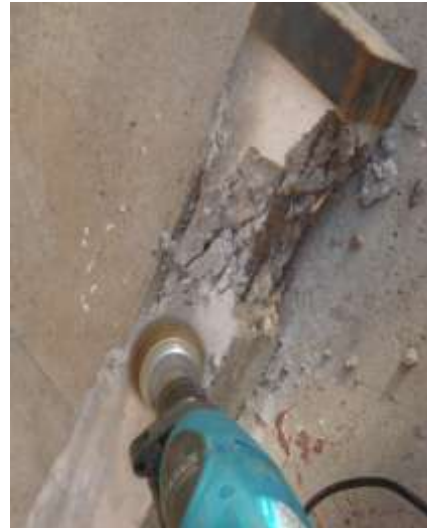
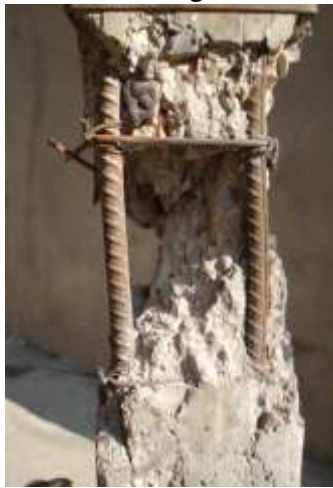
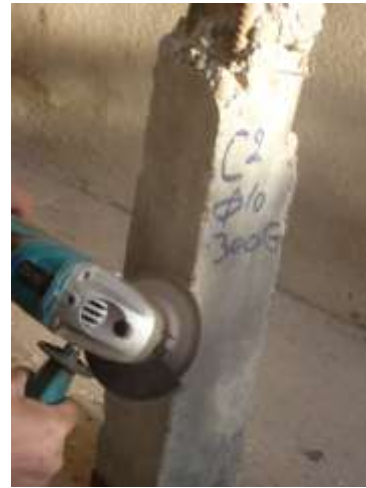
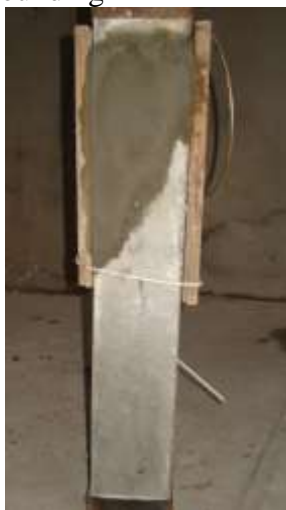
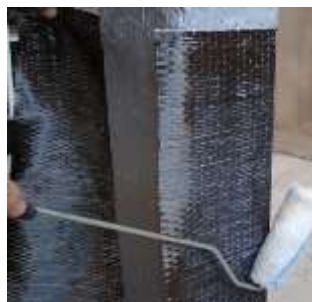
A-Brushing the concrete to remove unsound materials and dust.

B-Repositioning the main reinforcement rounding

C- Rounding of columns corners

D-Replacement of

E- Wrapping the CFRP fabric sheet using a roller

damaged concrete to coat the CFRP Sheet with additional epoxy layer

Figure 5. Column specimen retrofitting procedure.

As shown in **Fig.5** the retrofitting procedure was as follows:

The unsound concrete was removed by using a steel brusher and the surface of the concrete was cleaned of all pink and sooty damaged concrete and any dust. Then the reinforcement was repositioned in its original place and ties were fixed. The damaged concrete that had been removed was replaced with concrete having the same mix properties. After 28 days, the corners of the column specimens were chamfered (rounded) at a width of 15 mm by grinding.

Two-component epoxy impregnation resin was mixed by hand according to the manufacturer's instructions and applied to the prepared concrete surfaces by brush. The fabric carbon fibers were cut out and wrapped around the specimen. A roller was used parallel to the direction of the fabric until the resin was squeezed between and through the carbon fibers. Two layers of CFRP were wrapped around the entire length of the column. According to the manufacturer's instructions, the CFRP fabric sheet must be covered by a second layer of epoxy.

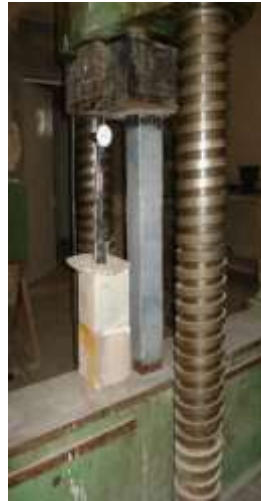
Figure 6. Test set-up ,Structural Lab - University of Al-Mustanseria.

The column specimens were tested in the rig shown in **Fig.6** using a testing machine with a 100 ton hydraulic jack capacity.

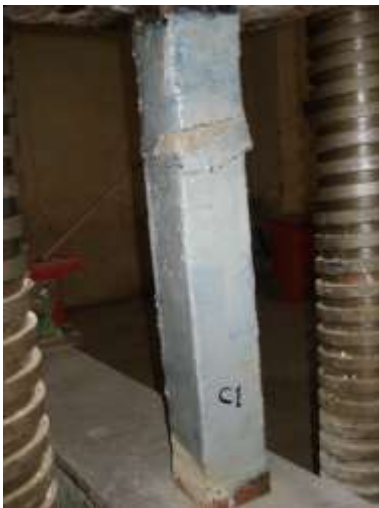
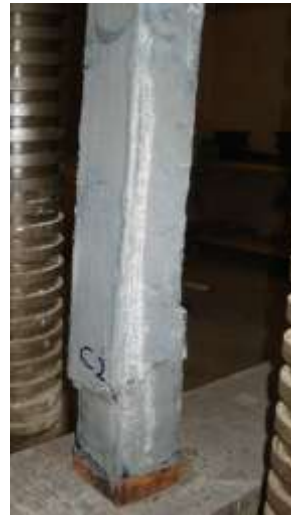
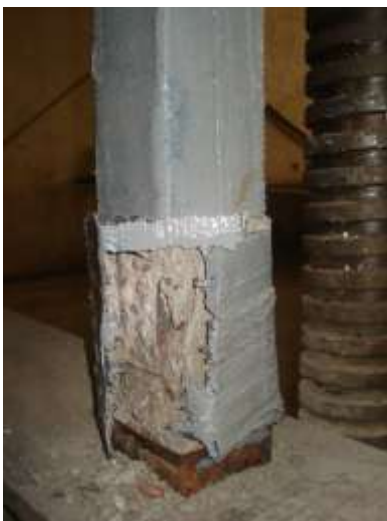
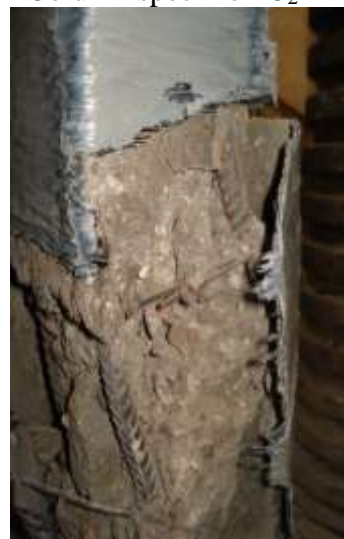
A-Column specimen C₁

B- Column specimen C₂

C- Column specimen C₅

D- Column specimen C₇

Figure 7. Failure of column specimens by rupturing of the two layers of CFRP.

Cracks could not be monitored due to the CFRP sheets wrapping the entire height of the specimens. Failure was sudden in all the specimens, with the explosion of the CFRP sheet and the destruction of the concrete core, as reported by ,**Ogata and Osada, 2000 and ,Massone, and Wallace, 2004** . However, this happened after recording a large scale of axial deformation compared to that recorded after burning and before using the CFRP sheets for retrofitting the specimens.

Failure occurred suddenly in a rapid progressive process. It was not possible to determine which event occurred before the other, namely the explosion of the CFRP wrapping, the crushing of the concrete core or the rapid buckling of the longitudinal steel reinforcement. **Fig. 7** shows the failure of retrofitted specimens with the same longitudinal reinforcement: C₁, C₂, C₅ and C₇. The control column specimens not exposed to fire flame are compared to the specimens exposed to different temperature levels, 300, 500 and 700 respectively. Specimens that exploded laterally after smashing the CFRP sheets of all the column specimens were recorded. Failure was more explosive and sudden in specimens C₅ and C₇ than that in specimen C₁. This means that the damage to concrete increases when increasing the exposure temperature, causing a greater burden on the CFRP sheet confining the column. Also, in most of the specimens, failure was observed at the outer, upper or lower third of the column, due to the flow of the axial stresses transmitted from the end bearing toward the middle of the column.

Axial deformation caused the specimens to expand laterally. After the first earlier loading period, this deformation occurred along with the destruction of the CFRP sheets as the load applied was increased. The epoxy-CFRP-epoxy sandwich behaved like a stiff, brittle composite layer. The load was shared by the rehabilitated concrete and the CFRP layers wrapped around it. The axial load was transmitted by the shear stress from the reinforced concrete core to the CFRP jacket. As load was increased and the specimen shortened (axial deformation), lateral deformation increased, acting on the CFRP which reacted by confining the concrete. On the other hand, the applied axial load was shared between the reinforced concrete column and the composite CFRP fabric sheet. Obviously, the composite CFRP fabric sheets had very little axial compressive stiffness, because of their small thickness in comparison to the concrete column. This caused the epoxy layer to break. Thus the main component of the composite sheet was the uniaxial fibers of the CFRP, which could not bear any axial compression load. Therefore the contribution of the axial load applied on the CFRP composite sheet was borne by the epoxy alone; however this value is so small it can be ignored. Thus, when a CFRP confined concrete column is subjected to axial load, the CFRP wrapping jacket is loaded by hoop tension while the concrete is subjected to triaxial compression ,**Nicolae, and Gabriel,2008**.

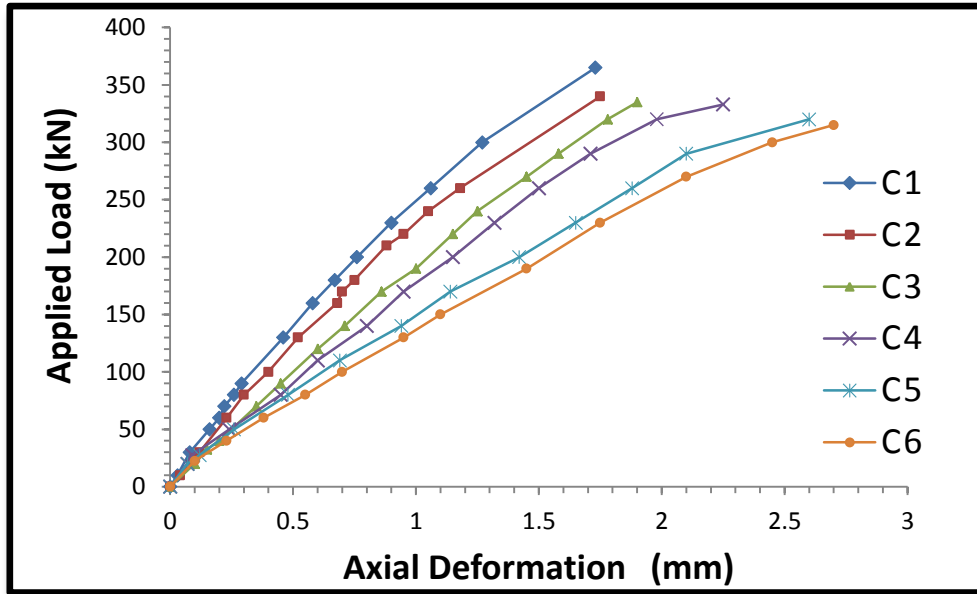
Figure 8. Load-Axial deformation curves for specimens with (4-Ø10mm) longitudinal bars . After retrofitting with CFRP fabric sheet.

Figs. 8 and 9 show the axial load deformation curves for the retrofitted column specimens versus the specimens reinforced with 8 longitudinal bars (4xØ10mm and 4xØ12mm).. The curves show an almost linear relationship, as recorded by **Triantafillou, 2003**, but the slope of the curves near the ultimate load fell little. Also, the figures show that the stiffness of the specimens decreases with increased exposure to fire flame temperature. As shown in **Fig. 8**, the stiffness of column specimen C₂ burned at 300°C, is slightly lower than that of unburned specimen C₁. While in **Fig .9**,

for the same compression between specimens C_8 and C_7 , stiffness was approximately the same with a slight difference near ultimate load capacity. In both **Figs. 8 and 9**, the stiffness of the retrofitted column specimens decreased with increasing exposure temperature. **Fig. 8** shows that the percentage decreases in stiffness in comparison to the retrofitted unburned specimen C_1 , were 5, 17, 24, 24 and 28% for specimens C_2 , C_3 , C_4 , C_5 and C_6 , respectively. While with the same comparison in **Fig. 9**, the percentage decreases were lower, with 2, 15, 21, 19 and 23% for specimens C_8 , C_9 , C_{10} , C_{11} and C_{12} , respectively, with respect to C_7 . This means that the confinement by the CFRP jacket becomes the main reinforcement and delays buckling.

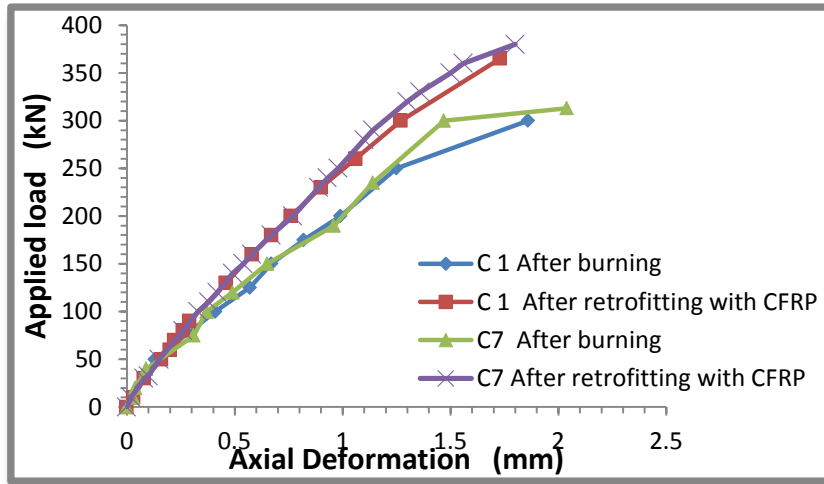
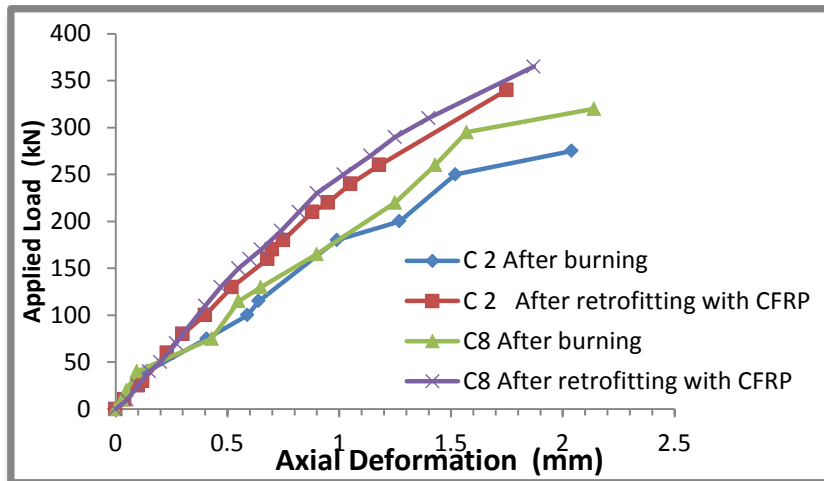
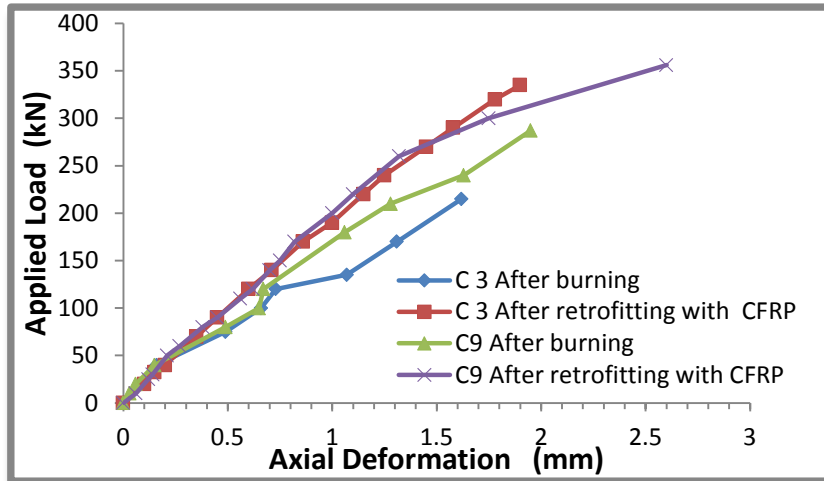
Figure 10. Load-Axial deformation curves for unburned column specimens After retrofitting with CFRP fabric sheet.

Figure 11. Load-Axial deformation curves for column specimens exposed to 300°C After retrofitting with CFRP fabric sheet.

Figure 12. Load-Axial deformation curves for column specimens exposed to 500°C and cooled gradually After retrofitting with CFRP fabric sheet.

Figure 13. Load-Axial deformation curves for column specimens exposed to 500°C and cooled suddenly After retrofitting with CFRP fabric sheet.

Figure 14. Load-Axial deformation curves for column specimens exposed to 700°C and cooled gradually After retrofitting with CFRP fabric sheet.

Figure 15. Load-Axial deformation curves for column specimens exposed to 700°C and cooled suddenly After retrofitting with CFRP fabric sheet.

The stiffness of the retrofitted specimens increased in comparison to the same specimens before retrofitting. **Figs. 10 to 15** show the difference in stiffness before and after retrofitting the column specimens exposed to the same burning conditions. The average difference was 10% for the specimens not exposed to fire flame and 14, 12, 10% for specimens exposed to 300, 500 and 700 °C, respectively. **Sandeep et al., 2007**, concluded that CFRP helps to increase strength without excessive increase in stiffness.
