**Rehabilitation of Reinforced Concrete Deep Beam by  
Epoxy Resin**

**Adnan Sadiq Al-kuaity\***

This investigation presents an experimental and analytical study on the behavior of reinforced concrete deep beams before and after repair. The original beams were first loaded under two points load up to failure, then, repaired by epoxy resin and tested again. Three of the test beams contains shear reinforcement and the other two beams have no shear reinforcement. The main variable in these beams was the percentage of longitudinal steel reinforcement (0, 0.707, 1.061, and 1.414%). The main objective of this research is to investigate the possibility of restoring the full load carrying capacity of the reinforced concrete deep beam with and without shear reinforcement by using epoxy resin as the material of repair. All beams were tested with shear span-depth ratio 2.2. An analytical study was made to show the behavior of a sample of test beam at higher stages of loadings before and after repair. The test results showed that the epoxy resin used for repairing was very efficient in restoring full capacity of failed beams. Moreover, epoxy resin increased the strength capacity of the origi

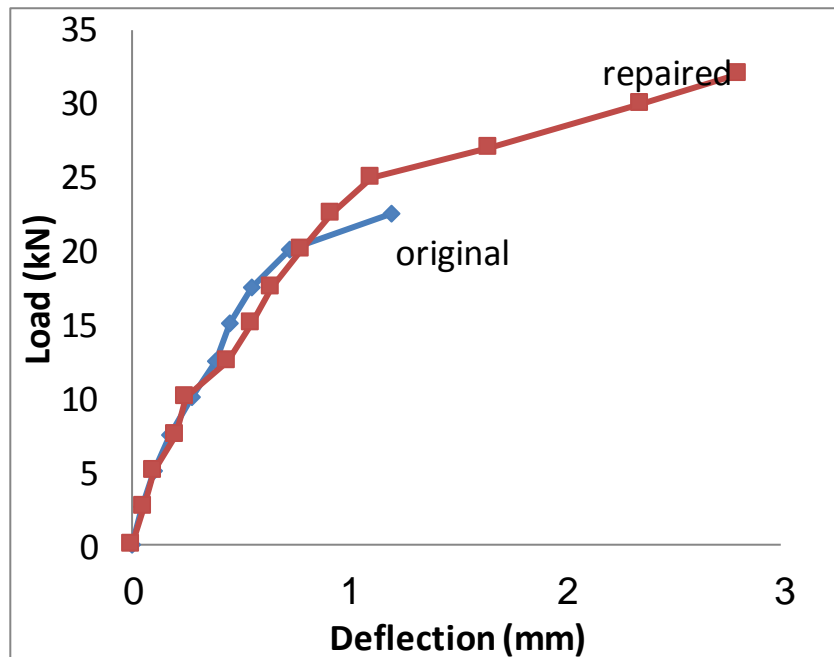
Figure 6. Load- deflection curve for B5.

The original beams were tested under two point loads by a universal machine used for standard flexural test of the prism. Deflections were measured at mid-span using mechanical dial gauge at stages of loading. Load-deflection curves are shown in **Figs. 4, 5 and 6**. Cracks are also observed during the loading and marked on the beams. When the load reached the maximum capacity of the beam, failure of beams occurred in different modes. The ultimate strength of beams and modes of failures are given in **Table 4**.

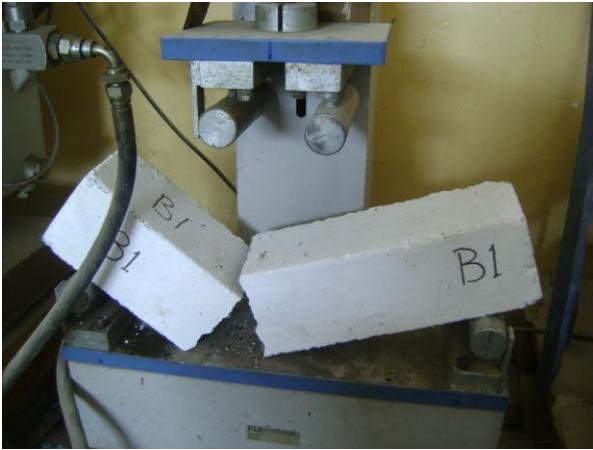
**Figure 7.** Failure of original beam B1.

Single crack penetrated suddenly within the mid-span of the beam (B1) which led to fracture the beam into two parts as shown in **Fig. 7**. The failure is very brittle because the beam has no steel reinforcement. A similar type of failure was observed for beam after repair as shown in **Fig. 8**.

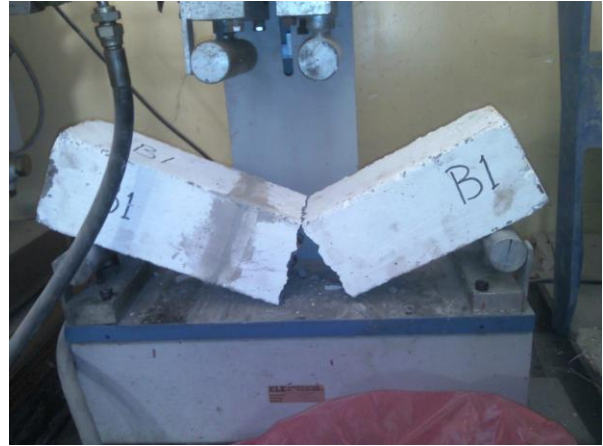
**Figure 8.** Failure of beam B1 after repair.

On the other hand, all planes of failures of repaired beams were shifted away from the original strengthened plane of failure as shown in **Figs. 8, 10, 12, 14 and 16**. This means that the epoxy resin is effectively acting restoring the full integrity of the failed beam with higher strength than the original concrete. The repaired beams show similar behavior under loading as those for original beams but with improved ductility.

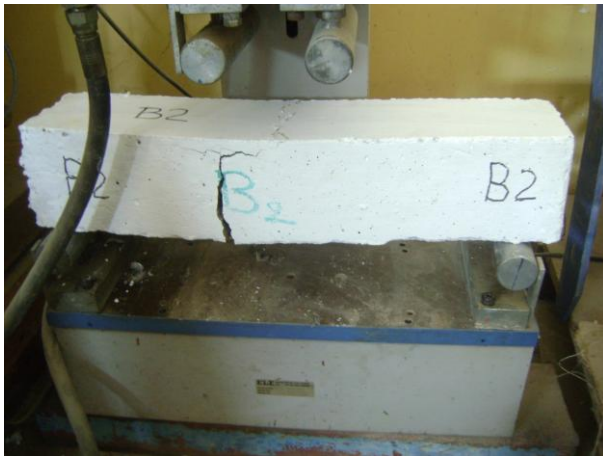
**Figure 9.** Failure of original B9.

More ductile mode of flexural failure was obtained for the beam (B2) with higher load capacity. The increase in load capacity is due to the presence of 2Ø6 longitudinal reinforcement in this beam compared to (B1). The reinforcement in B2 prevented sudden failure. Major crack initiated under the point load and penetrated upward to the compression zone resulting in failure of the beam. The mode of failure is shown in **Fig. 9**. Beam B2 after repair showed the similar mode of failure to the original beam as shown in **Fig.10**.

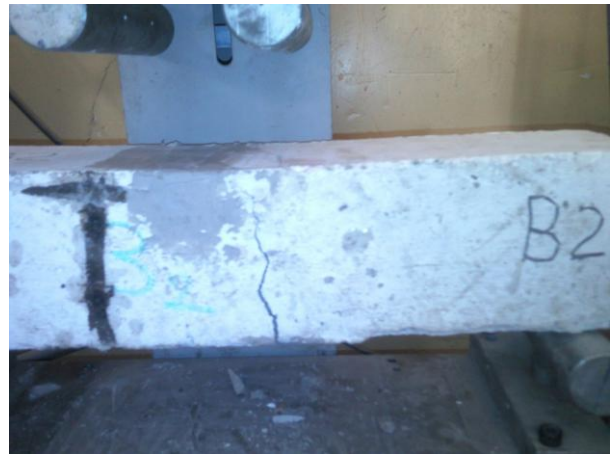
**Figure 10.** Failure of beam B2 after repair.

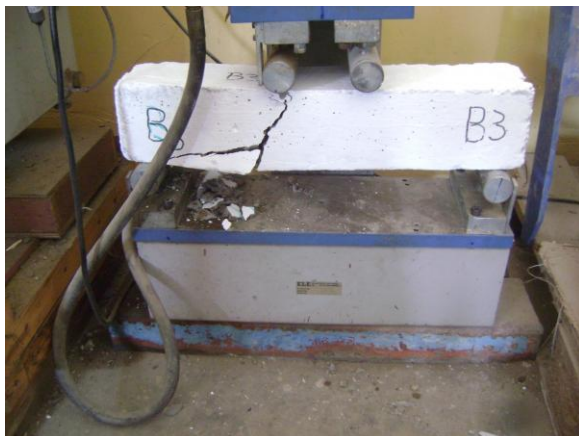
**Figure 11.** Failure of original B3.

Beam (B3) failed in shear due to the formation of inclined diagonal shear cracks. The increase in the steel reinforcement in this beam increases the flexural capacity of the beam but the minimum shear reinforcement provided was not adequate to resist applied shear. Therefore, shear cracks formed in the shear span. The main diagonal crack penetrates towards the point load resulting in crushing the compression zone under point load as shown in **Fig.11**. The repairing material in the beam (B3) strengthened the failure plane which shifted the failure plane to the left support as shown in **Fig. 12**.

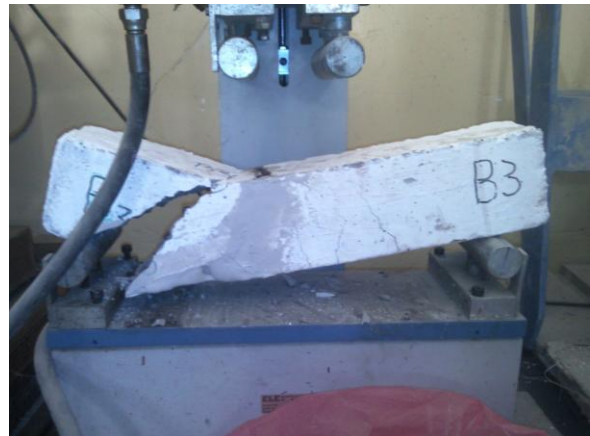
**Figure 12.** Failure of B3 after repair.

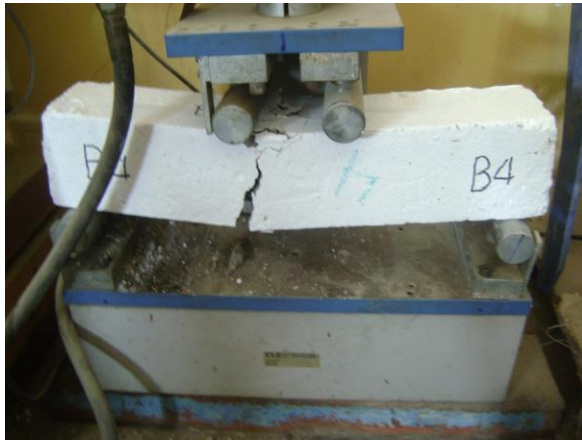
Figure 13. Failure of original B4.

(B4) has a similar mode of failure as B3 but it carries a higher load than B3. This is because of higher steel percentage in tension zone. The mode of failure of beam B4 is shown in **Fig.13**. After repair, (B4) showed a similar failure mode as the original beam as shown in **Fig. 14**.

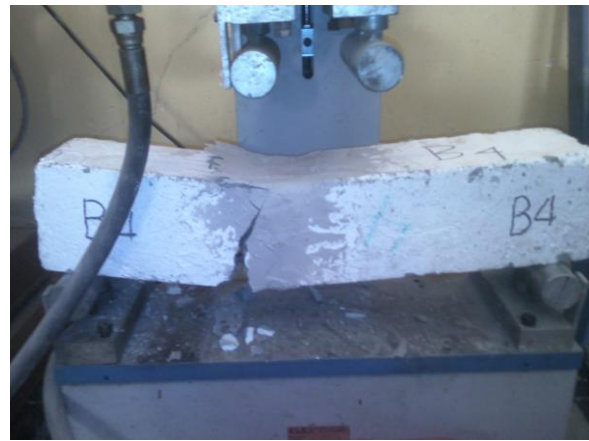
Figure 14. Failure of B4 after repair.

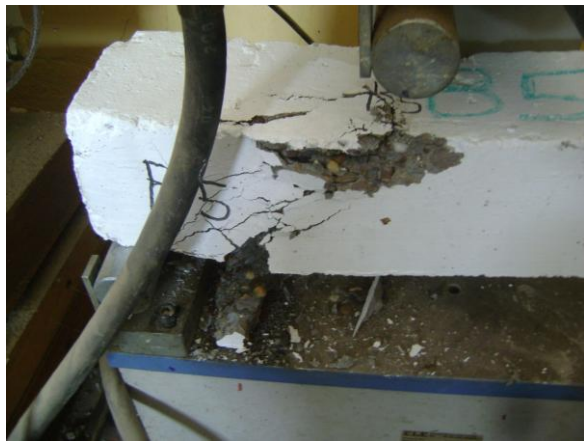
Figure 15. Failure of original B5.

(B5) showed a different mode of failure than other beams. The presence of higher longitudinal steel in (B5) relative to others changed the behavior of the beam into similar to tied arch and then load transferred through concrete strut connecting point load with support. The mode of failure of (B5) is due to the crushing of concrete strut. The mode of failure is shown in **Fig. 15**. This means that the deep beam would not act like tied arch unless sufficient amount of longitudinal steel reinforcement is provided. Test beams showed the increase in longitudinal reinforcement significantly increases the ultimate capacity of the deep beam. The ultimate load and the mode of the failure of all tested beams are given in **Table 4**. Analysis of shear strength by, **ACI-318, 2005** agreed well with the test results of the original beams as shown in **Table 5**.

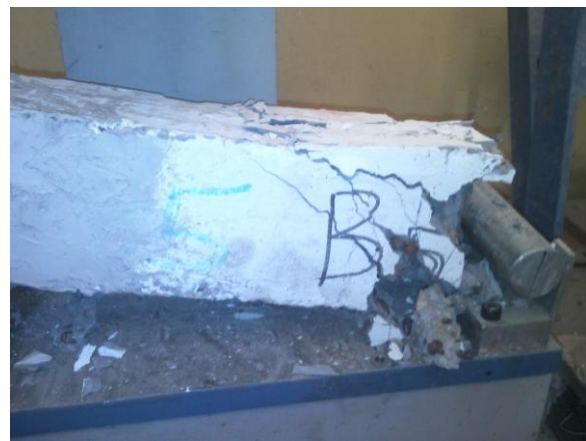
Figure 16. Failure of B5 after repair.

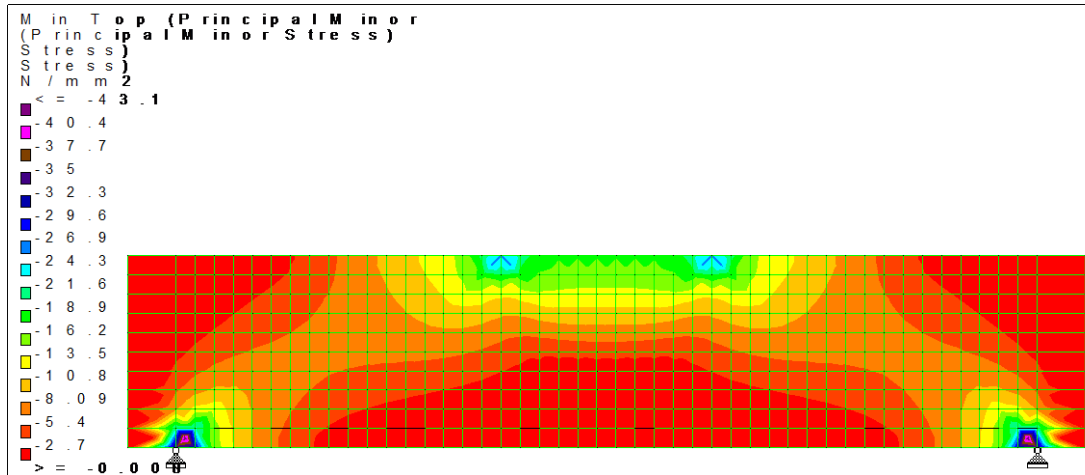
Figure 19. Typical stress distribution along the original beam.

Beam (B5) is selected here for comparison since this beam is failed by tied rib-bearing before and after repair. The computer analysis showed the minimum principal stresses distribution in the beam (B5) before and after repair as shown in **Figs. 18, 19**. The shape of stress distribution indicates clearly the arch action as suggested by, **Rogowsky and Mac Gregor, 1983, CEB-FIP, 1990 and Foster and Gilbert, 1998**.

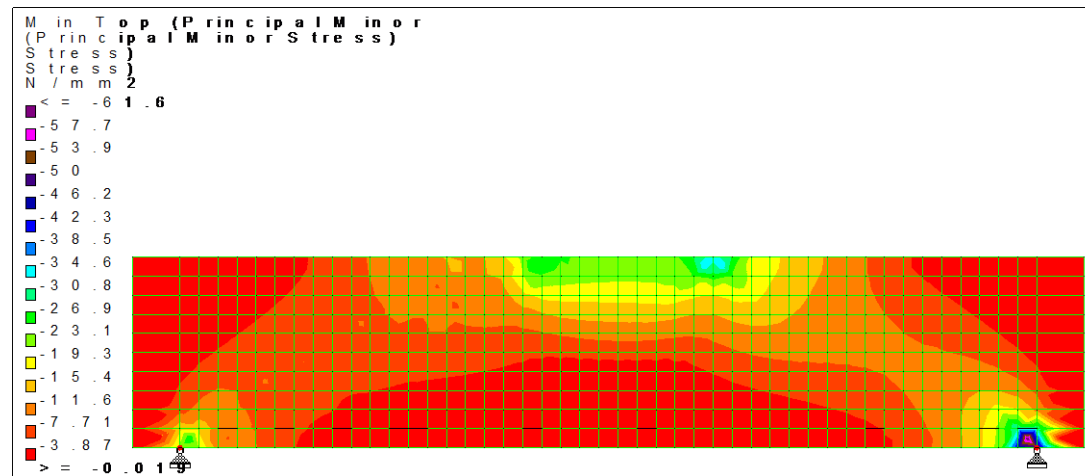
Figure 20. Typical stress distribution along the beam after repair.

Computer model in **Fig. 20** shows that the stress distribution of repaired beam B5 is shifted from the repaired side to the other side of the beam. In this case, crushing of concrete along the failure, plane took place at another side as shown in **Figs. 20**. However, the computer analysis agrees well with test results. Therefore, the epoxy resin used here for repairing the failed beams is very effective in restoring the full capacity of the failed beams with an increase in the strength capacity.

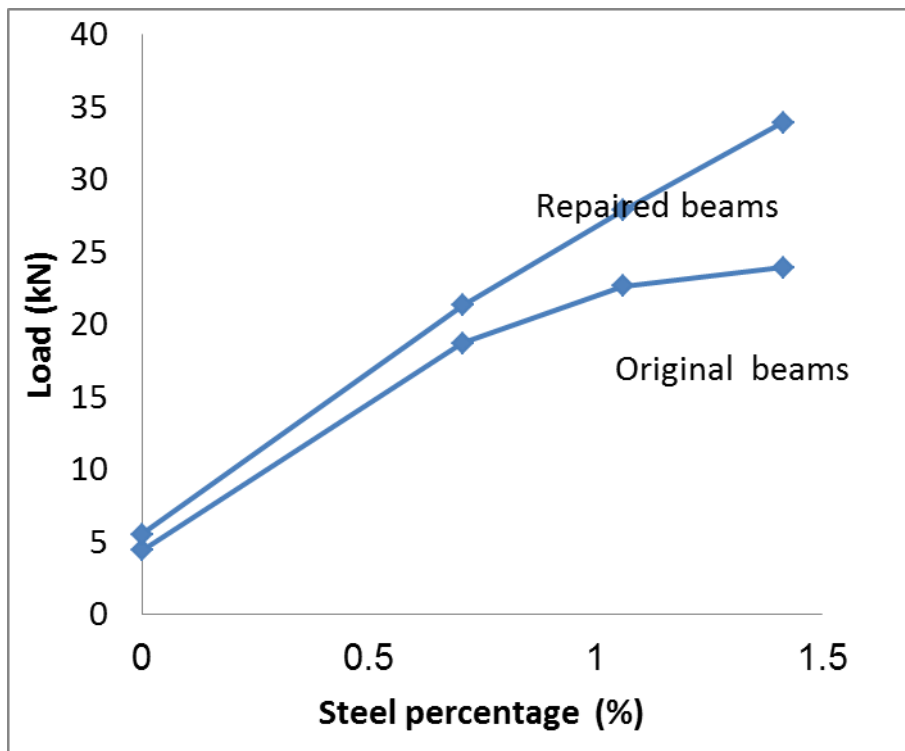
**Figure 21.** Effect or steel reinforcement on an ultimate load of repaired beams.

**Fig. 21** shows the relationship between longitudinal steel ratio and load carrying capacity of deep beams. The increase in the steel ratio significantly increases the load carrying capacity of the beams irrespective of the mode of failure.
